EDO-EPS Method Applied for Rehabilitation of Expressway Hit by Earthquake

Central Nippon Expressway Company Limited.
2-18-19 Nishiki Naka-ku Nagoya
Aichi 460-0003 JAPAN

Abstract

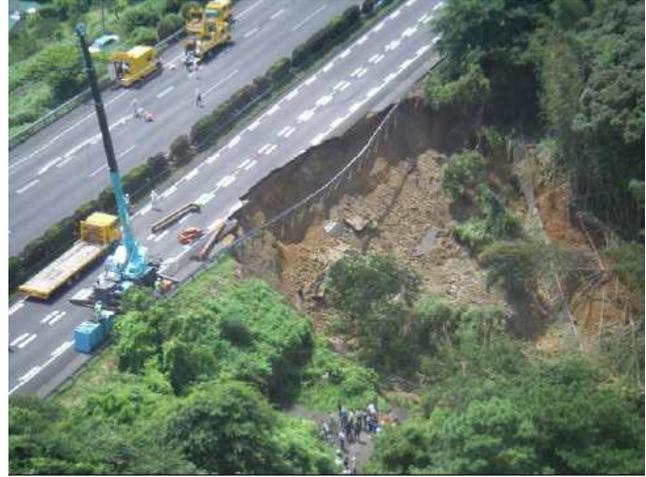
On August 11th, 2009, at 05:07 am, an earthquake of M 6.5 hit central Japan with its epicenter near the Suruga Bay. It damaged part of an embankment on the Tomei Expressway as approx. 40 m of the outer lane failed. This is one of the most important major expressways in Japan, and the traffic was immediately stopped. Since it happened on the first day of a week's mid-summer holiday observed all over Japan, an urgent rehabilitation work was called for.

Photo1 Collapsed embankment^[1,2]

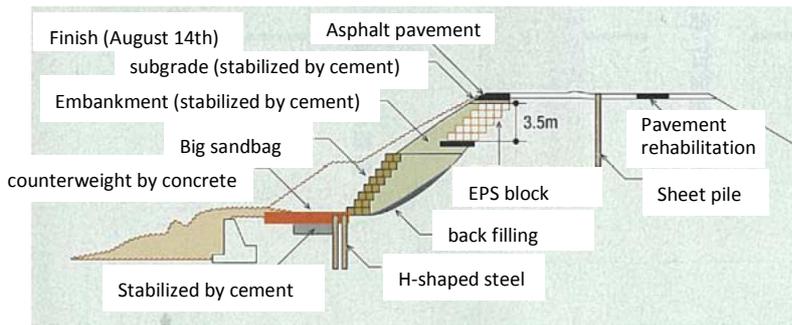
Fig.2 Emergency rehabilitation work plan design in cross-section^[3]

The emergency rehabilitation work started at around 14:00 on the day of the earthquake. Originally, it was planned to pile H-beams in the collapsed ground to stop further soil slides. However, vibration of piling might possibly induce further soil slides, and a big rock hidden underground was encountered during piling operations preventing further piling activities. Consequently the repair method was changed to another alternative, that is: H-beams were first to be piled in the base layer of the embankment as reinforcement, then large sandbags were stacked up from the base layer step on step upward so finally a new embankment might be completed on the top layer by applying stabilizing cement material as reinforcement.^[3]

After that, concrete counterweight fills were formed on the lower layers of the embankment so as to provide further reinforcement to the base structure. Two thirds (2/3) of the collapsed embankment was restored in the first two days, but the remaining one third (1/3) was expected to take more time before completion. Application of the EPS method was determined on August 14th counting on its capability of fast work execution in addition to the benefit of the light weight of the embankment as a whole. Necessary amount of EPS blocks, then available from stock in a factory situated quite far away, was transported non-stop to the site by a fleet of large trucks specially escorted all the way by police cars. EPS blocks were thus carried in to the site by late night of the same day. A great number of workers, in the meantime, were mobilized and put to work over night till the next morning when the work was completed; 3.5m high EPS fill with a total of approx. 500m³ of EPS blocks used. Fig.2 shows the cross-section of the rehabilitation work plan. Photo.2 shows the work completed.

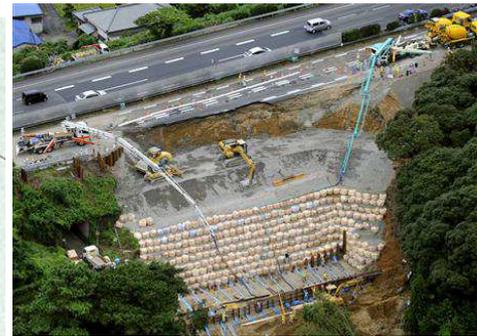
Photo2 Emergency rehabilitation embankment in view

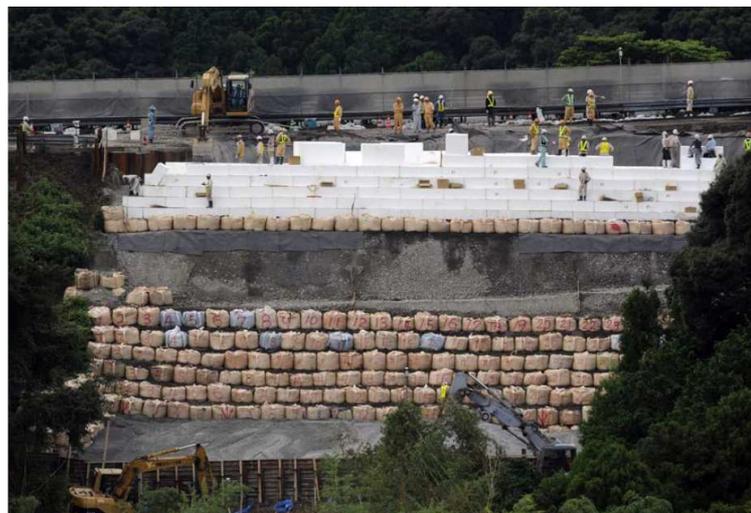
Photo 3 EDO-EPS blocks being laid.

Concrete slabs (10cm or 15cm thick) are, usually, placed between the EPS blocks and the road pavement so as to disperse the traffic loads. However, since fast restoration was the top priority in this case, a sub-base of cast-in-place concrete that necessitates a curing period, was not applied. Instead, sub-base of materials treated with soil stabilizing cement (55cm thick at the thinnest) was used to substitute the concrete slab. The type of EPS blocks used was D-20 (density 0.20kN/m^3 , compressive strength 50kN/m^2), however, D-25 with still higher compressive strength (density 0.25kN/m^3 , compressive strength 70kN/m^2) was specially applied to the top layer, while a geotextile was put in between the EPS blocks and cement treated sub-base layer. With all works concerning the placement of EPS blocks and road surface pavement now finished, the whole emergency restoration work was completed on August 16th at midnight 0:00 am. Thus, the road was re-opened to traffic at the site about five days after it was hit by the earthquake. Photo.3 shows the EPS method at work on the site. Photo.4 shows the emergency rehabilitation completed.

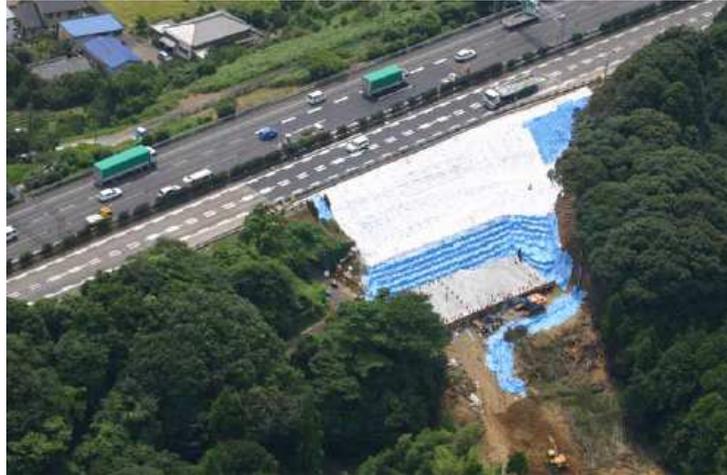
Photo 4: Emergency work just finished^[1]

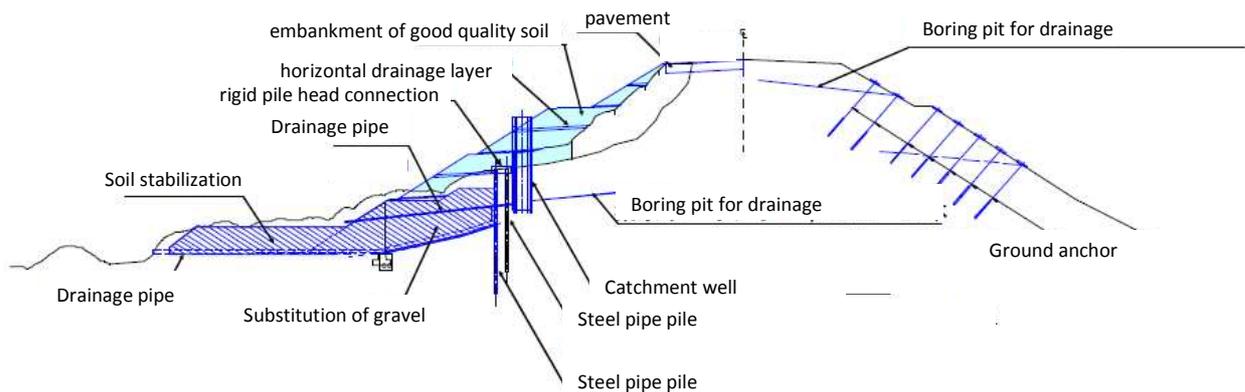
Soon after completion of the emergency work a committee meeting of experts and specialists was held, where analysis and studies were made on the cause of the collapse of the expressway as well as on the repair measures for full-scale rehabilitation of the embankment. The base of the collapsed road embankment was found forming an A-shape (reversed V, or chevron) across the road, and pan-bottom shape along the length of the road. Accordingly this was a topographical condition liable to water influx and accumulation on its inside. And as a mechanism that worked at the time of the earthquake it was estimated that mudstones present in the lower layer of the embankment had significantly lost its strength due to the effect of constant influx of the ground water over many years. This had in turn lowered the permeability and as a result raising the underground water level inside the embankment, which induced by the earthquake action, consequently aided in causing the collapse of the road embankment.^[2,3]

Fig. 3 Cross-section of full-scale permanent work ^[5]

As a measure for the permanent full-scale rehabilitation of this site, it was determined that the most important factor was to establish proper drainage conditions inside the embankment and also to improve the stability of the embankment base. The full-scale restoration work should start toward the end of October 2009 with a time target to finish it before the start of the rainy season (mid-June) of the next year.

Now, the sub-base placed on top of the EPS blocks and treated with soil stabilizing cement in this emergency rehabilitation work measured 55 cm in thickness at its thinnest part, which is equivalent to a thickness much larger than 3 times that of the normally applied concrete slab layer (10cm). It was therefore considered that proper dispersion of traffic loads would be obtained (45° dispersion within the pavement/sub-base; 20° dispersion within EPS blocks).

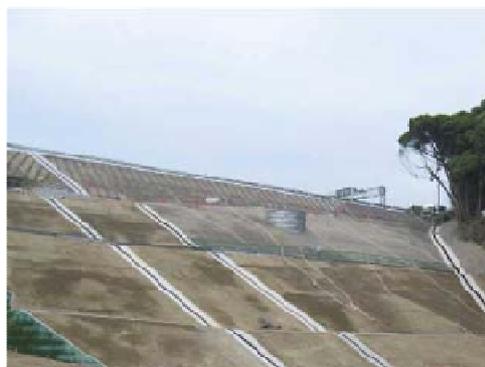
Photo 5: Full-scale permanent work completed. ^[5]

Rehabilitation work for the embankment’s main body was completed on June 8, 2010 and the incidental works other than the main lanes of the expressway were completed as well toward the end of July 2010 to finalize the whole scope of the work.
