Tire wear particles, tire leachates and road treatments: a Norwegian case study

Elisabeth Rødland, NIVA

Road tunnels in Norway

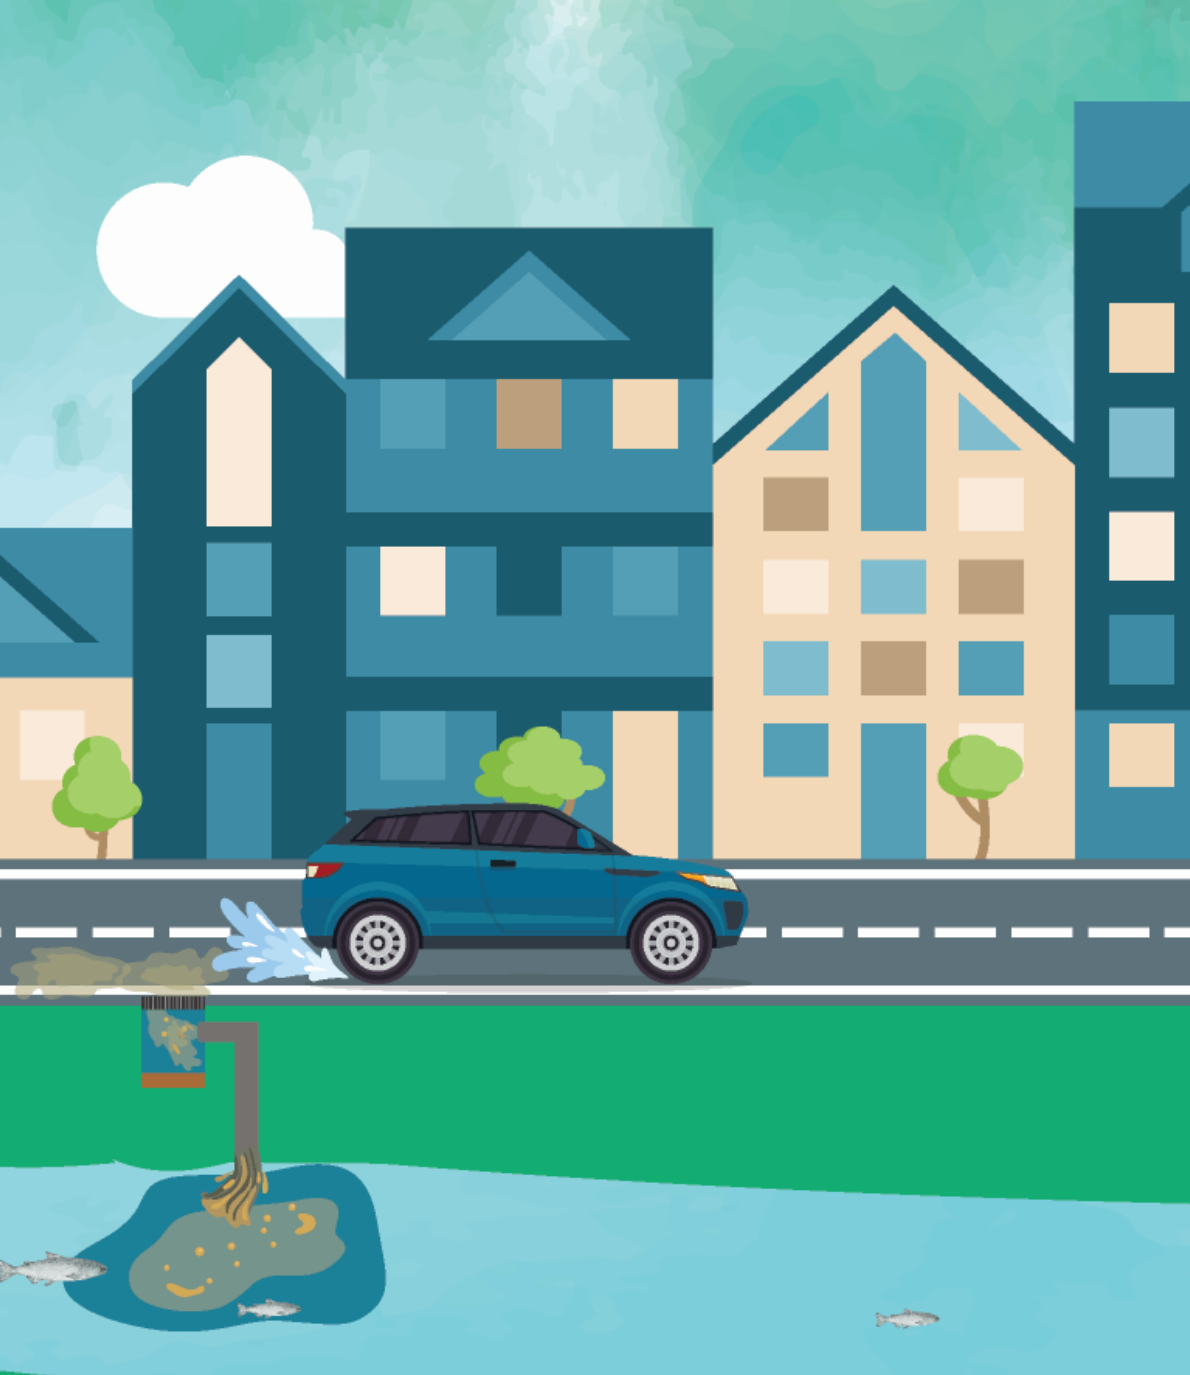
PYR-GC/MS

Rødland et al., 2022. A novel method for the quantification of tire and polymer-modified bitumen particles in environmental samples by pyrolysis gas chromatography mass spectroscopy, *Journal of Hazardous Materials*.

Tires

Different blends of SBR and BR rubber

Road asphalt

Polymer-modified bitumen containing styrene butadiene styrene rubber (SBS)

Markers

SBR+BR+SBS

SBR+BR

SBS

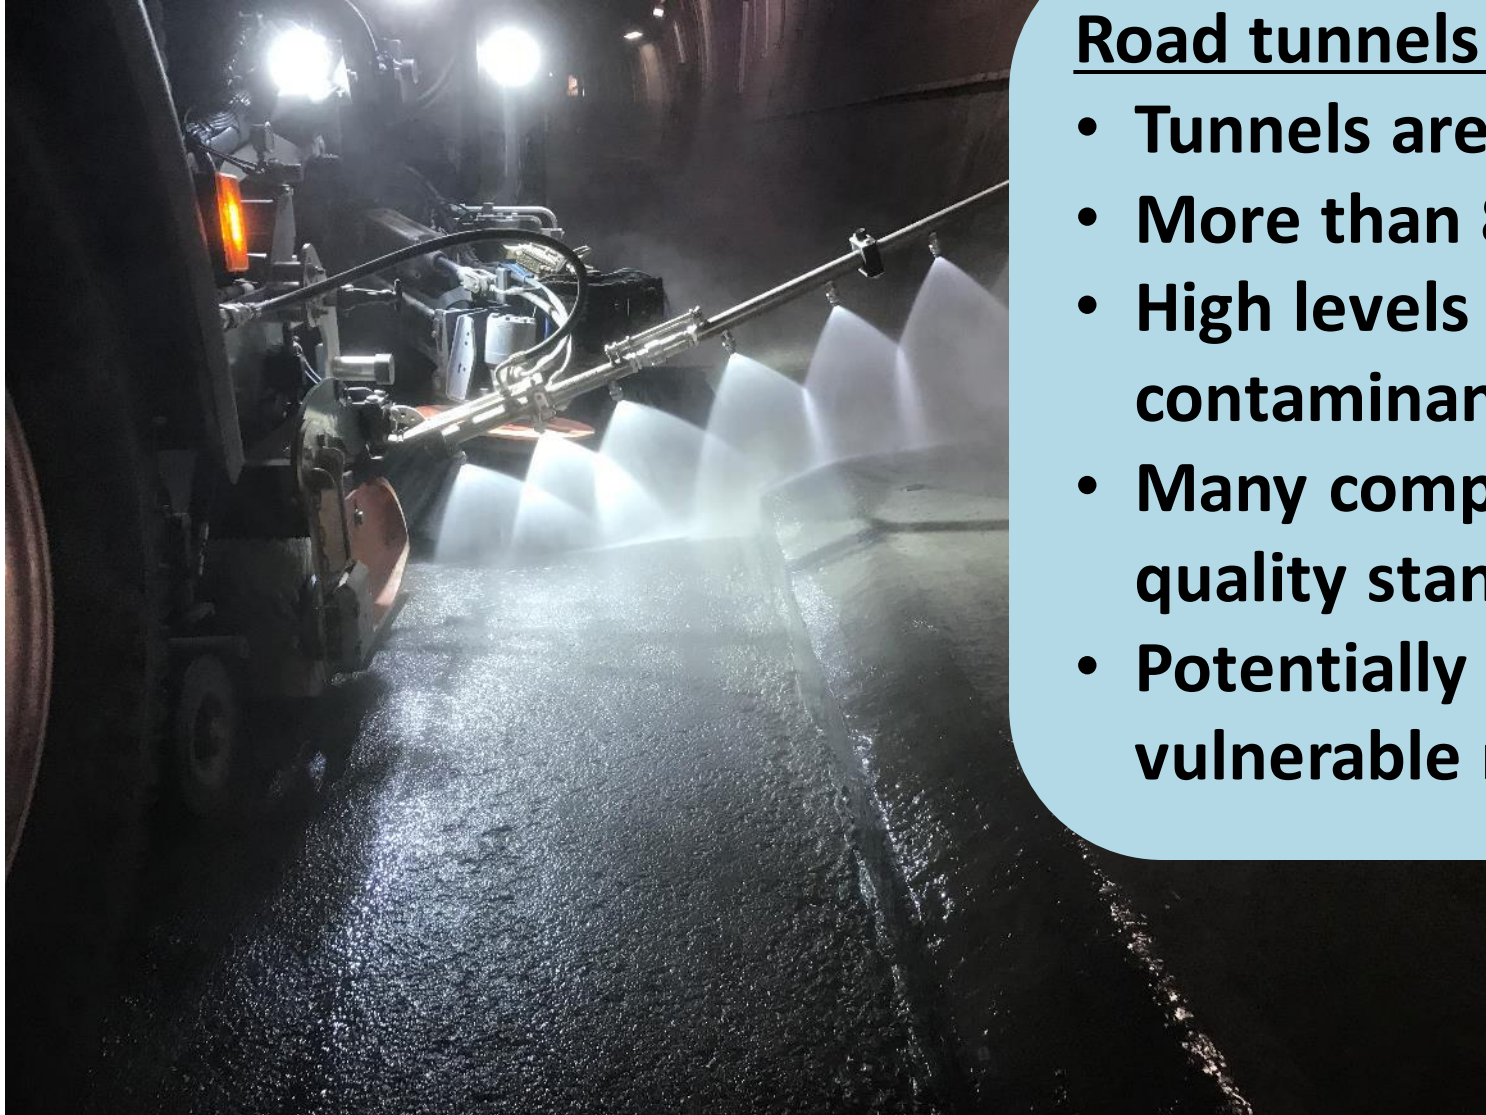
- Tunnels are washed regularly
- More than 80% without treatment
- High levels of TSS, metals, PAH, organic contaminants
- Many compounds above environmental quality standard (EQS)
- Potentially high environmental impact in vulnerable recipients

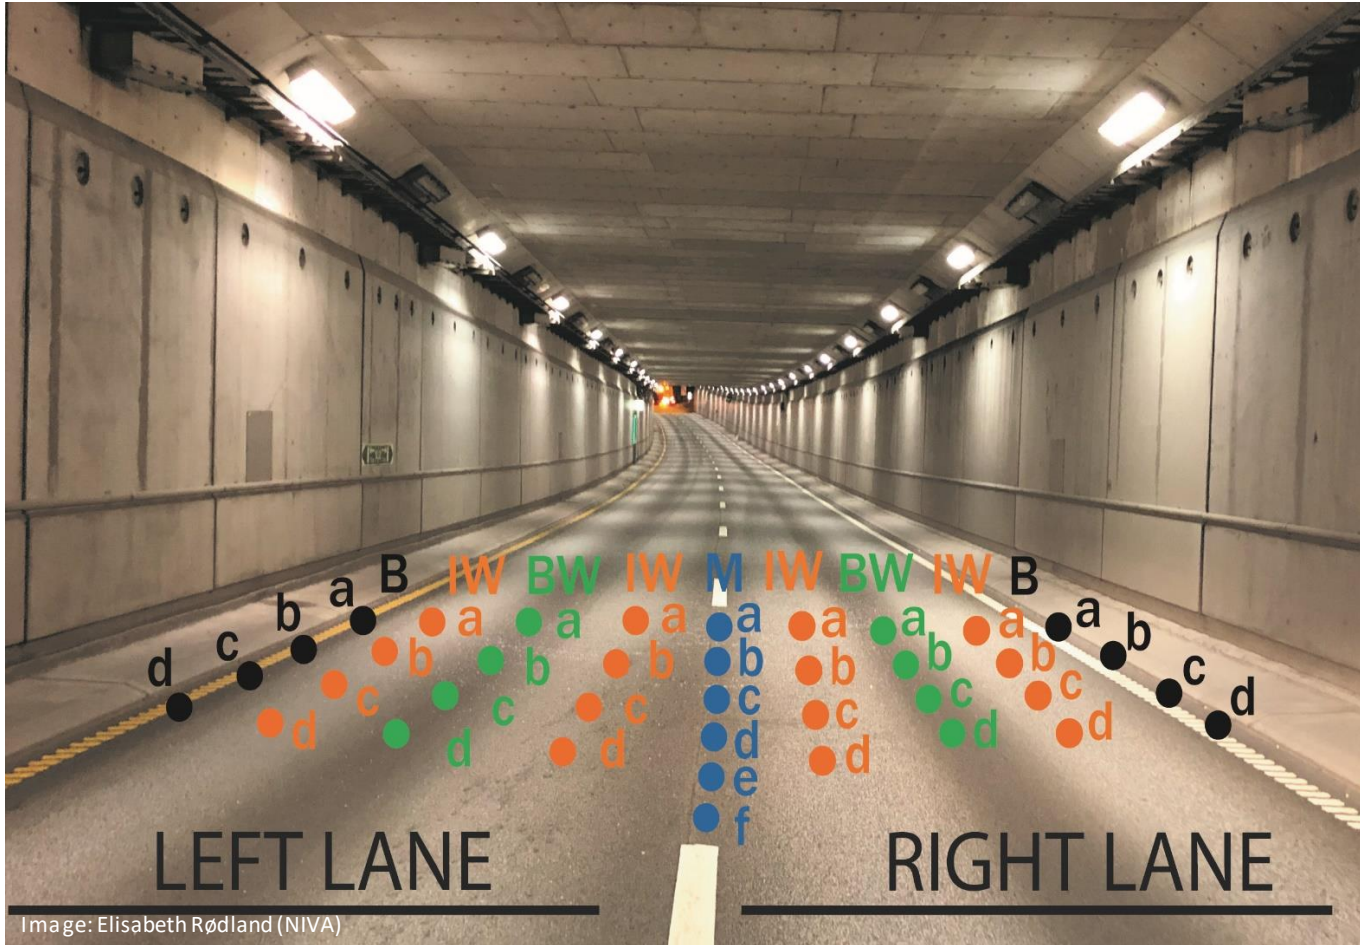
ROAD DUST

WET DUST SAMPLER

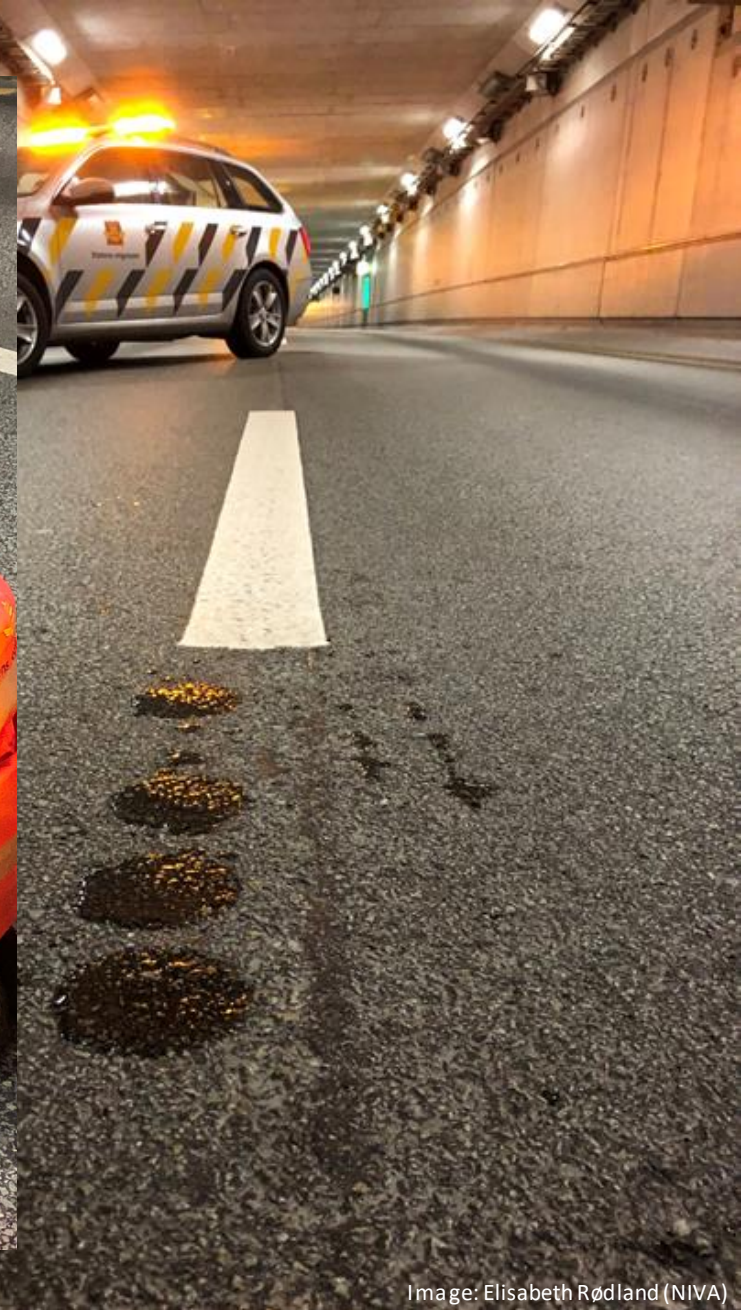
ROAD SEDIMENT

Gully-pots*

- Highest concentration close to inlet
 $53.1 \pm 1.33 \text{ mg/g}$

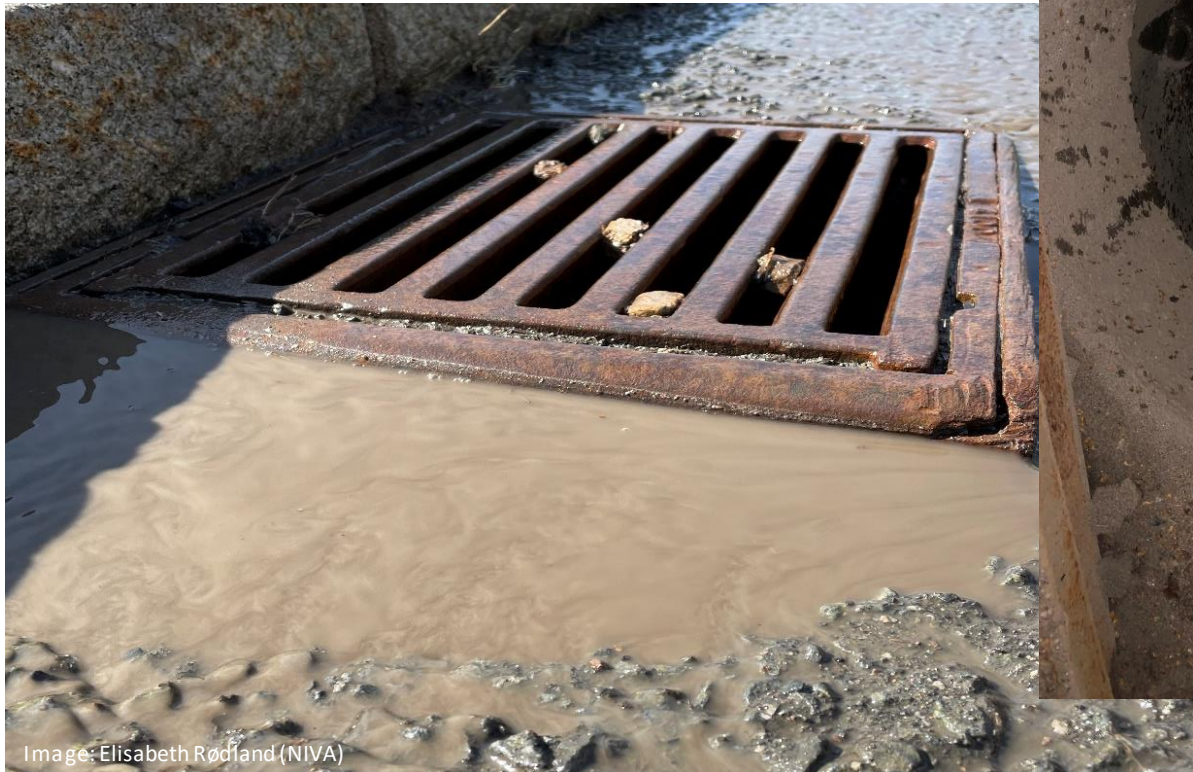
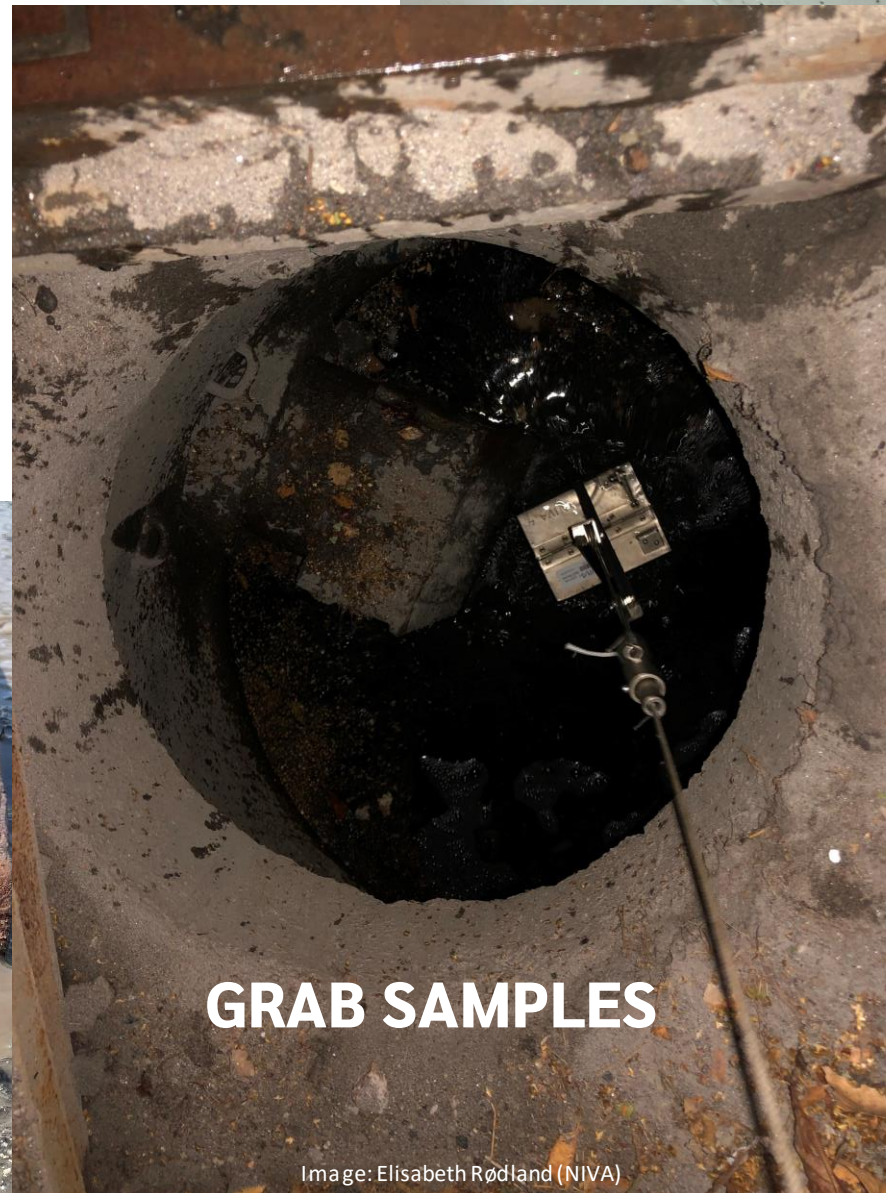
GRAB SAMPLES

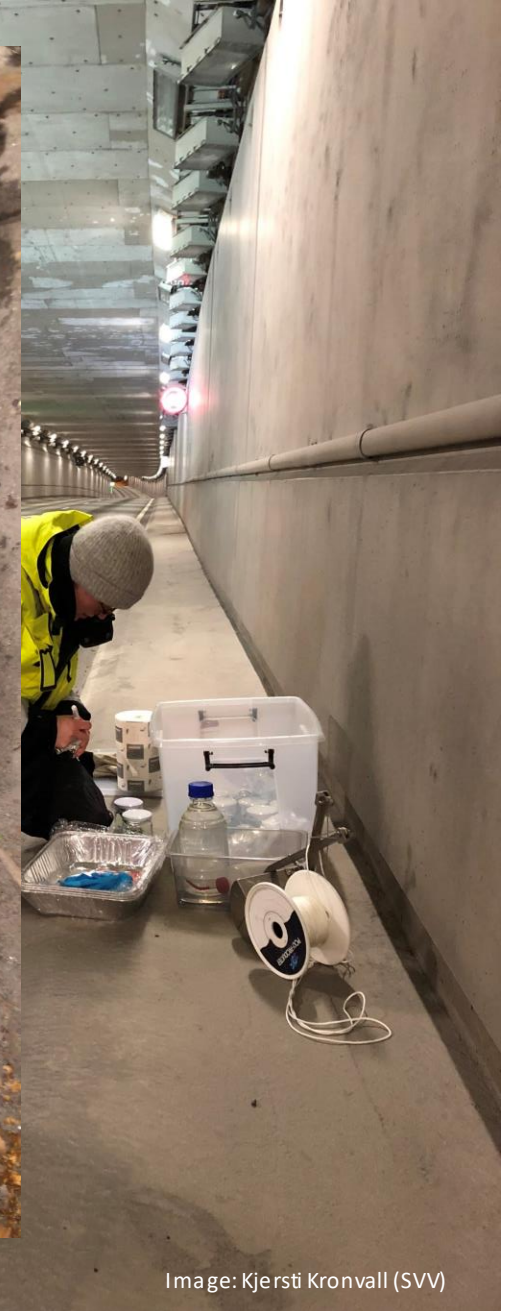
TUNNEL WASH WATER

Tunnel wash*

- Large variation in TWP levels during the wash and during release f treatment
- Inlet: 14.5 - 47.8 mg/L (3)
- Outlet: 6.78 to 29.4 mg/
- 63% retention

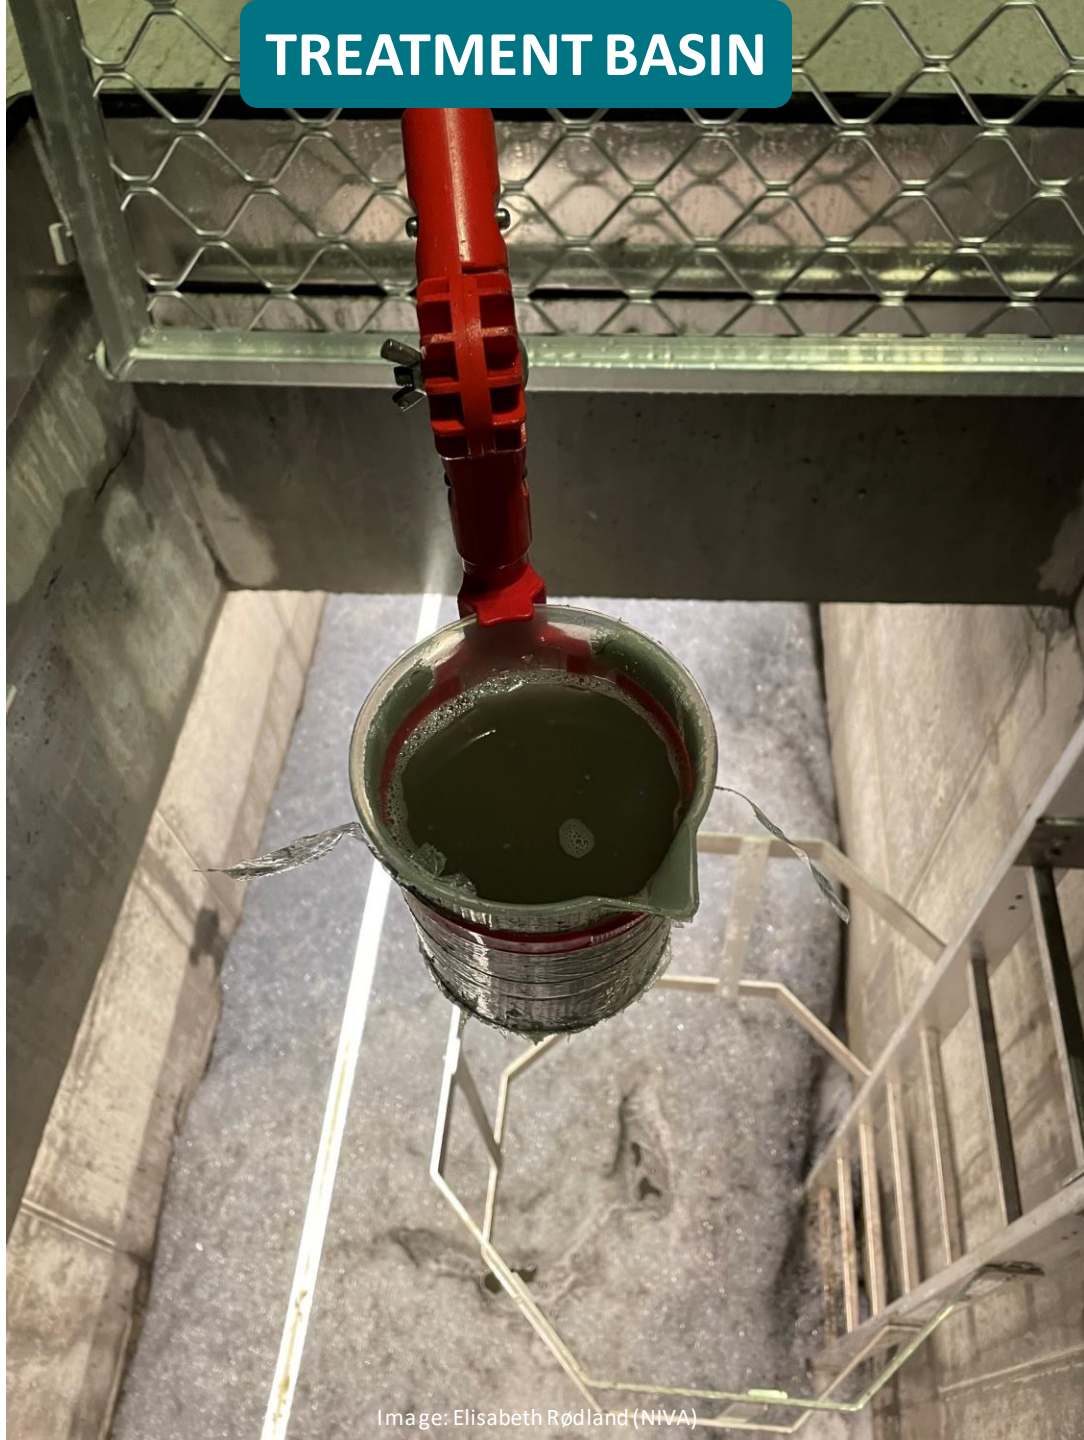
Vålerenga tunnel Oslo 2023*

TREATMENT BASIN

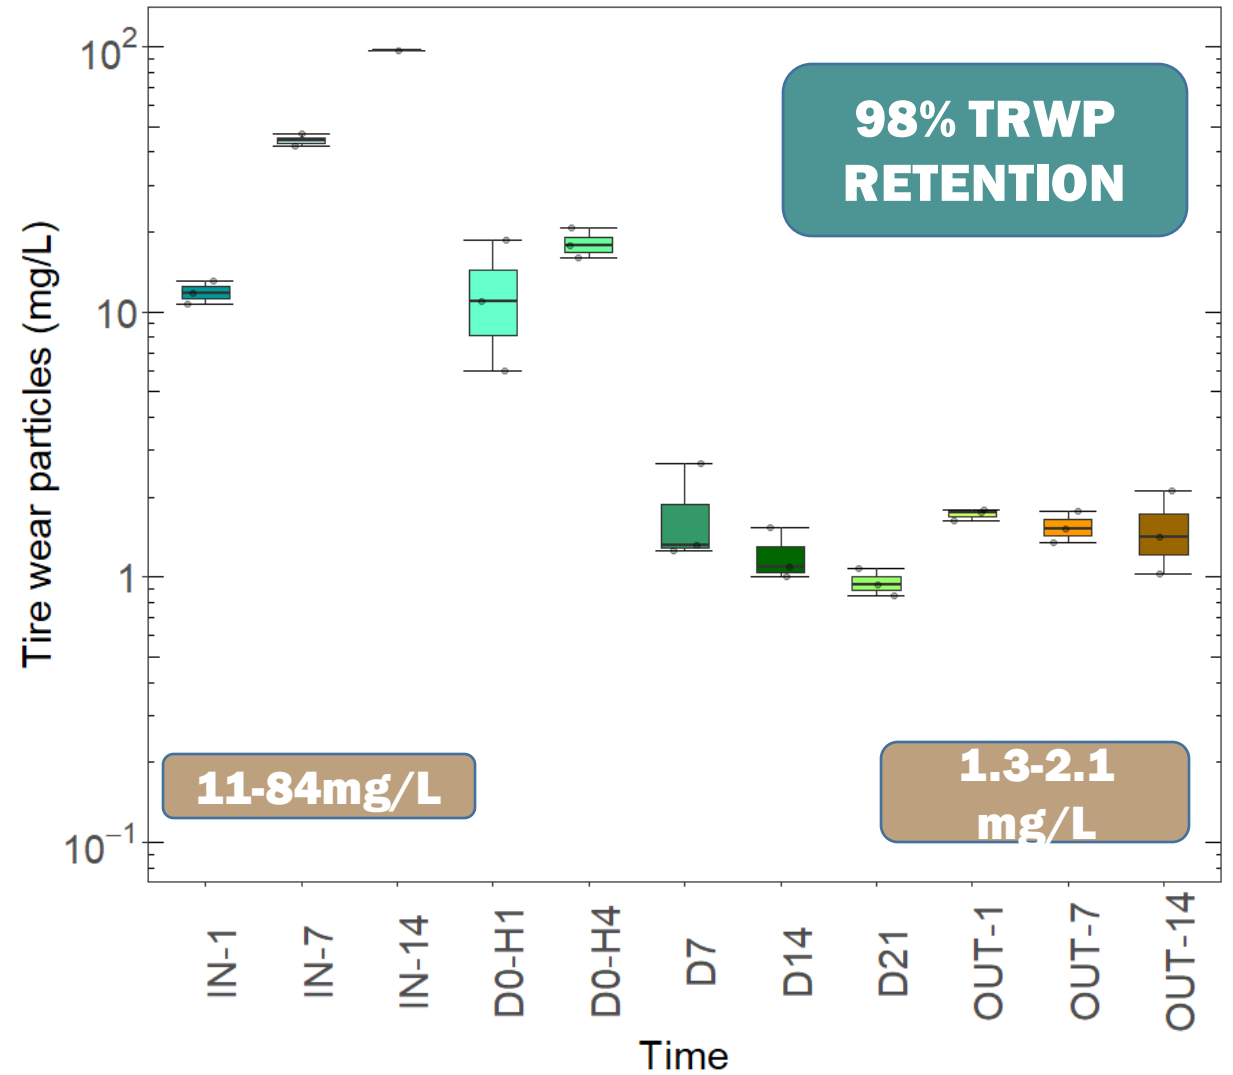
TREATMENT BASIN

Transformation

Treatment of tire-related chemicals?

Discharge levels higher than inlet water

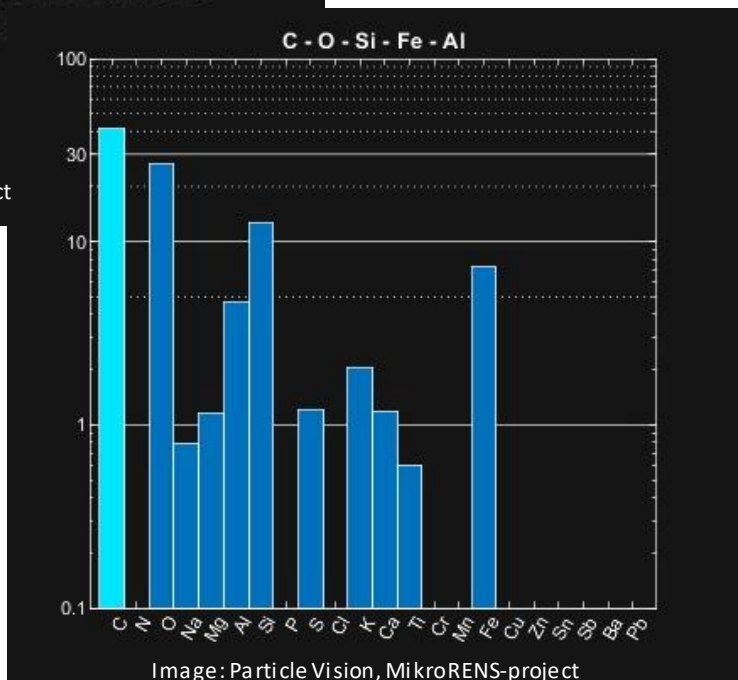
COMPARISON STUDY BETWEEN PYR-GC/MS AND SEM-EDX

Vålerenga tunnel Oslo 2023**

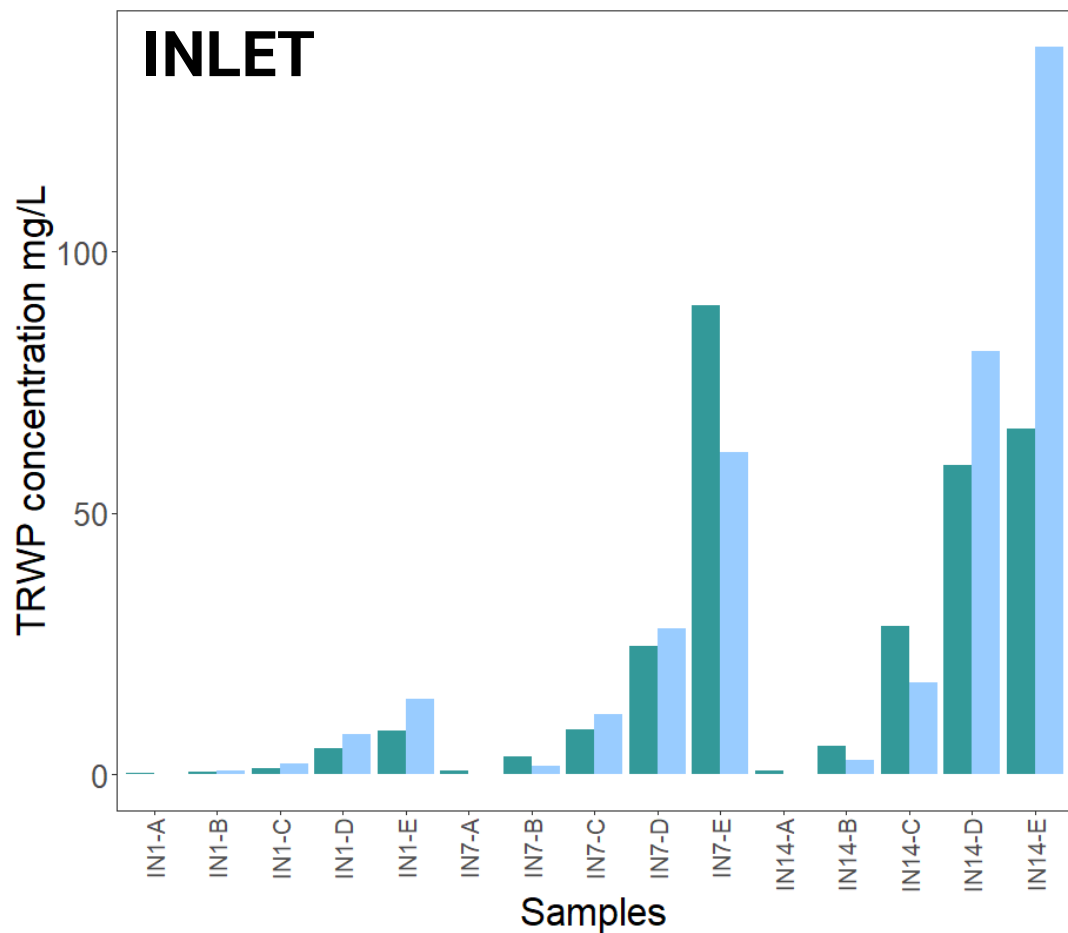
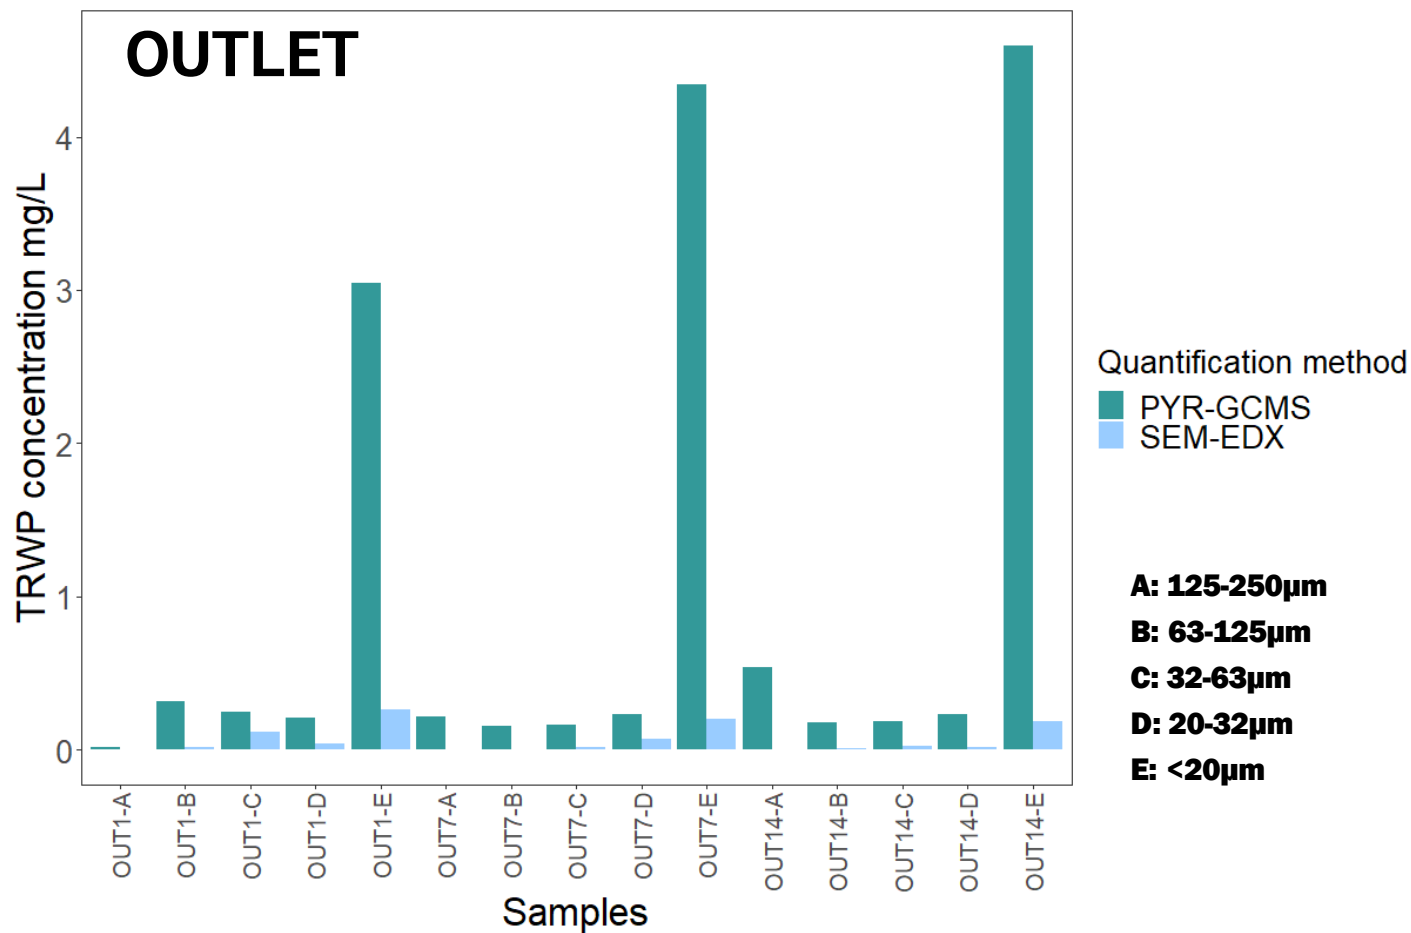
COMPARISON STUDY BETWEEN PYR-GC/MS AND SEM-EDX

SEM-EDX → difficult to distinguish TRWP and RWP <10µm?

PYR-GC/MS: Influence on markers in out samples?
