# Unbound crushed concrete in high volume roads – A field and laboratory study

The paper discusses these field-lab contradictions with reference to a field trial at highway E6 south of Trondheim. There crushed concrete is used as sub-base layer in a pavement designed for rather heavy traffic (ADT > 10000).

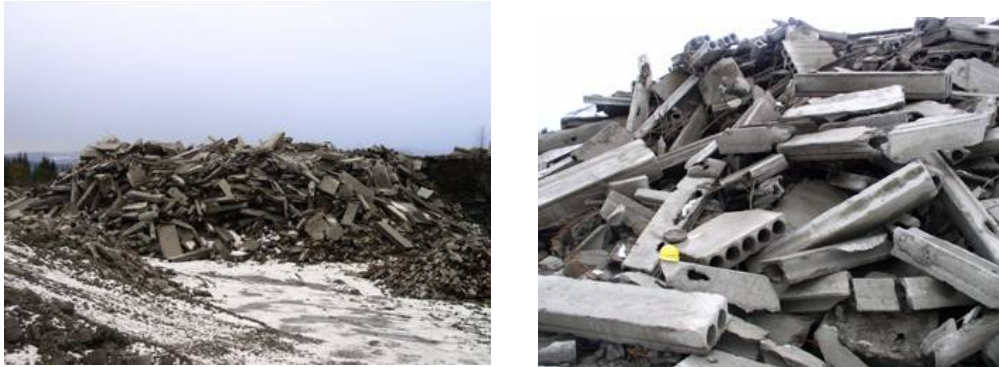
Figure 3: Element concrete stockpile

The origin of the alternative sub-base materials was discarded pre-fabricated element concrete as shown in Figure 3.

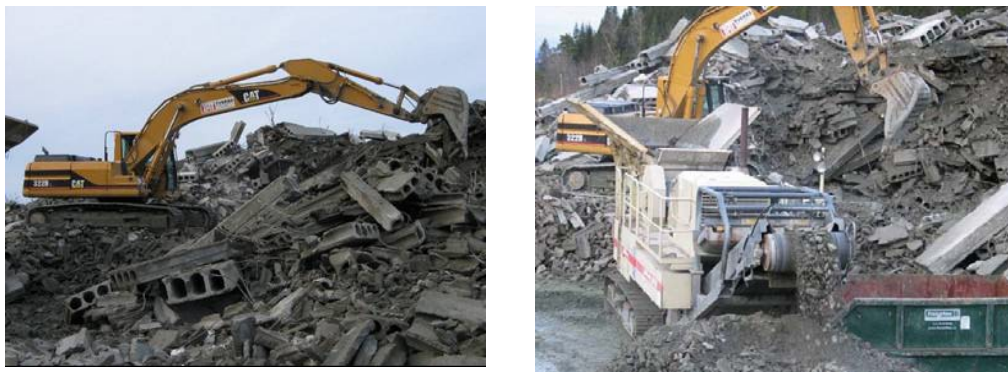
Figure 4: Material production; crushing and separation of reinforcement bars

The concrete elements were crushed in a mobile crushing mill which also separated (most of) the reinforcement. The crushed materials were then fractionated into the two required products 0-100 mm and 20-100 mm.

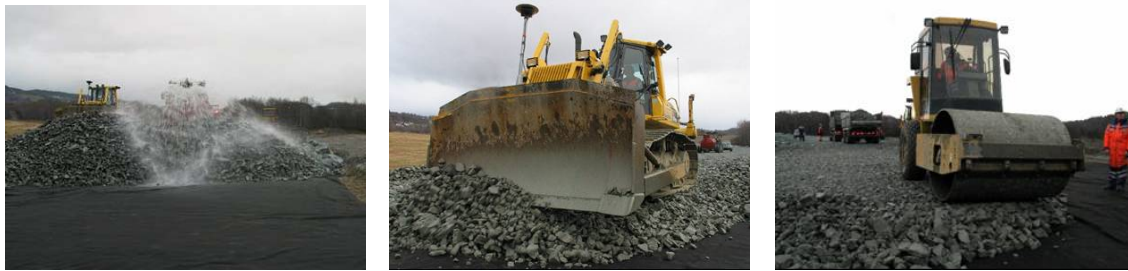
After dumping on the test site, the materials were sprinkled with water before compaction in two layers á ca 30 cm (Figure 6).

Figure 6: Sprinkling of crushed concrete materials is recommended before paving and compaction

*Water absorption:* Due to the porosity, these aggregates will in some cases behave quite differently from natural materials. Hence, water absorption is an important parameter for materials as crushed concrete. Some precautions are recommended in order to avoid fragmentation, such as water sprinkling (Figure 6). Data for the Melhus materials are shown in Table 1.

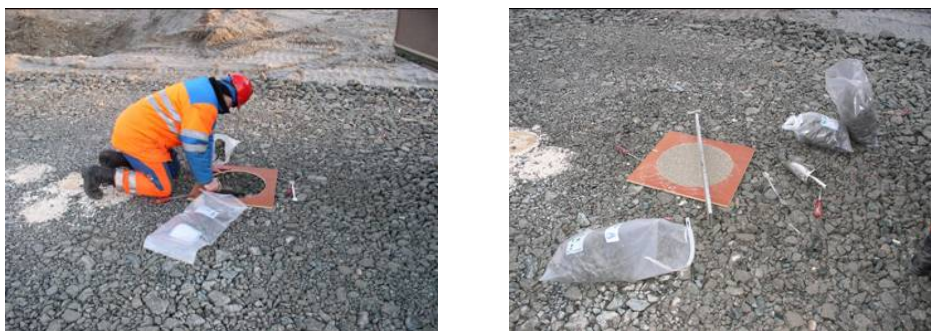
Figure 7: In place detection of density/unit weight (sand replacement method)

After compaction, the in situ dry densities were detected as shown in Figure 7. These values were to be used as input to the further laboratory tests.

Field densities and water contents were measured in situ after compaction (Figure 7). These became the target values when compacting specimens for triaxial tests in the lab. Two parallel samples of each fraction were tested. As can be seen from Table 4, the twin samples were almost identical.

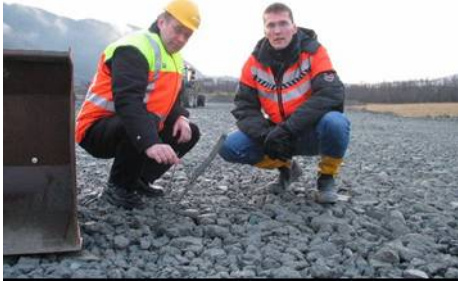
*Contaminants:* The importance of “clean”, well-sorted materials was also clearly demonstrated; during the first two hours of construction work three truck tires were punctured by remaining reinforcement steel bars!

Figure 8: Remaining steel bars may cause a lot of trouble
