# **UNBOUND CRUSHED CONCRETE IN HIGH VOLUME ROADS – A FIELD AND LABORATORY STUDY**

The paper discusses these field-lab contradictions with reference to a field trial at highway E6 south of Trondheim where crushed concrete was used as sub-base layer in a pavement designed for rather heavy traffic (ADT > 10000).

Late autumn 2003 two test sections with unbound crushed concrete as sub-base layer were constructed as part of a new Highway E6 at Melhus, 20 km south of Trondheim, Norway. Two different concrete materials/fractions were tried out; 0-100 mm and 20-100 mm. A number of field measurements were conducted, both during and after construction, in order to gain further practical experience with these kinds of materials. Parallel to the field investigations, an extensive laboratory program was carried out on the same materials.

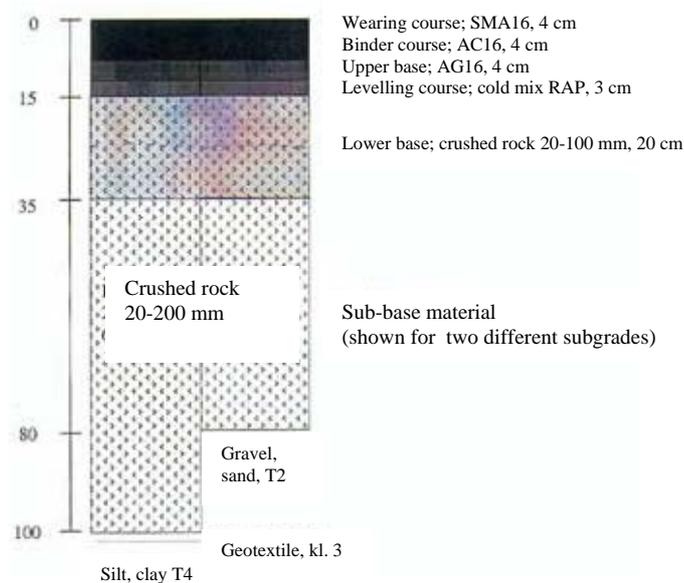
**Figure 1:** Pavement construction at E6 Melhus, layer details

The E6 highway is the “backbone” of the Norwegian road network, stretching 2580 km from south-east to the very north of Norway. At this specific site at Melhus, the road is designed for an annual daily traffic ADT = 12.500. The standard construction for the new road is 15 cm of asphalt on top of 65-85 cm crushed rock materials as shown in Figure 1. On the test sections, shown in Figure 2, the construction was modified by replacing the 45-65 cm crushed rock sub-base with a crushed concrete sub-base of the same thickness. This implies that the bearing capacities of these materials were assumed to be equivalent.

*Bearing capacity:* Plate bearing and FWD tests have been conducted on the test sections and on a reference section with standard pavement construction (Figures 1 and 2). The first results (based on FWD measurements performed on pavement surface immediate after construction) showed that the test sections with crushed concrete and

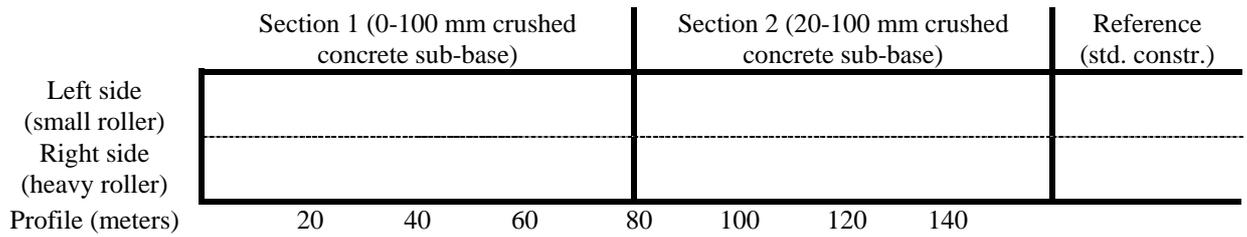
In order to compare the two alternative crushed concrete materials, two adjacent test sections á 80 m were constructed, as shown in Figure 2. For practical (engineering)

studies, one side was compacted with a lightweight roller (6 tons) and the other side with a heavy roller (15 tons).

**Figure 2:** Test sections, E6 Melhus

The results revealed no immediate advantages of using the heavy compactor, no significant differences between left and right side (Figure 2) were recorded. For section 2 with the coarser 20-100 mm material, max density (after 10 passes) was in fact obtained with the small 6 tons roller.

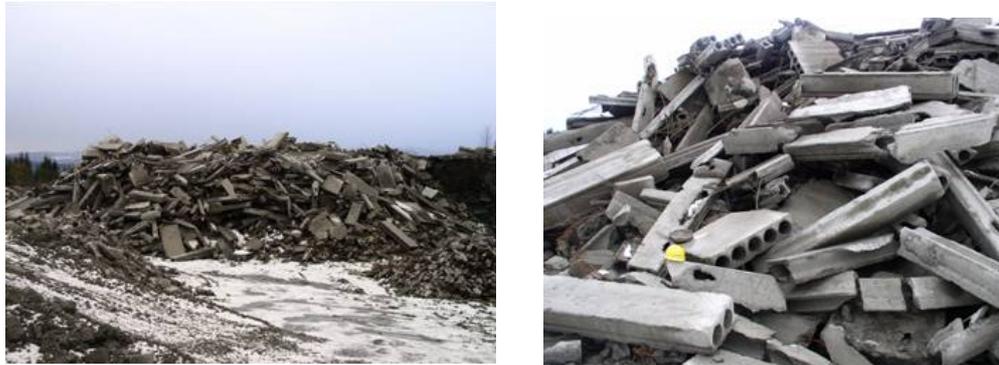
The origin of the alternative sub-base materials was discarded pre-fabricated element concrete, as shown in Figure 3.

**Figure 3:** Element concrete stockpile

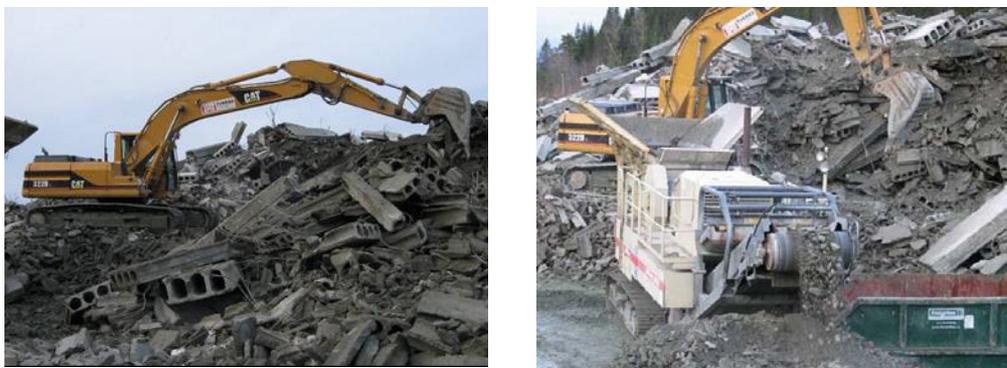
The concrete elements were crushed in a mobile crushing mill which also separated (most of) the reinforcement. The crushed materials were then fractionated into the two required products, 0-100 mm and 20-100 mm.

**Figure 4:** Material production; crushing and separation of reinforcement bars

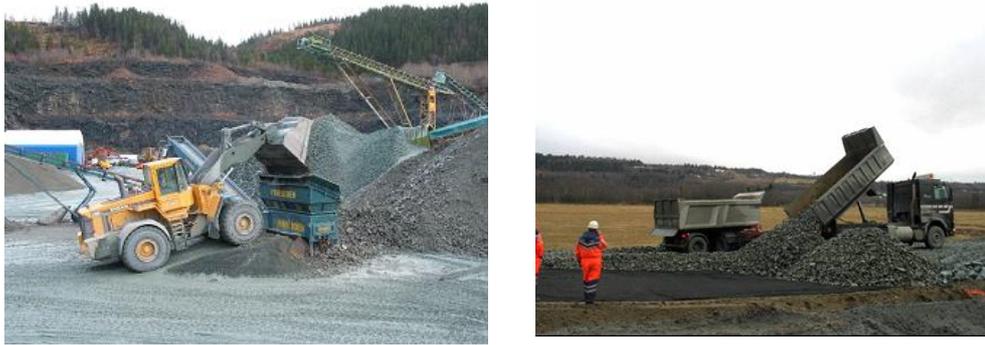
**Figure 5:** Material production; sieving and transport

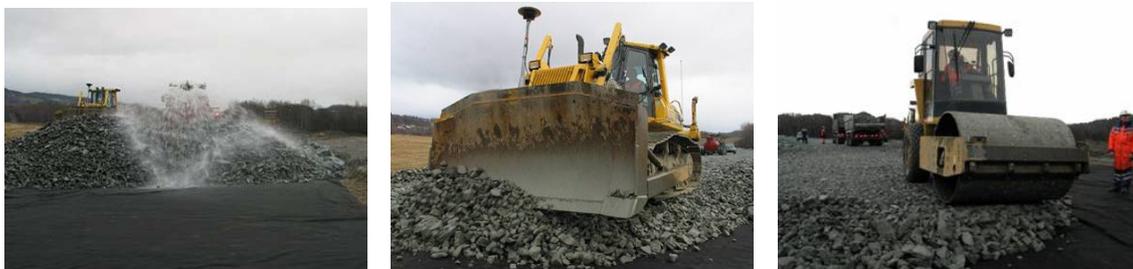
After dumping on the test site, the materials were sprinkled with water before compaction in two layers á ca 30 cm (Figure 6).

**Figure 6:** Sprinkling of crushed concrete materials is recommended before paving and compaction

*Water absorption:* Due to the porosity, these aggregates will in some cases behave quite differently from natural materials. Hence, water absorption is an important parameter for materials as crushed concrete. Some precautions are recommended in order to avoid fragmentation, such as water sprinkling (Figure 6). Data for the Melhus materials are shown in Table 2.

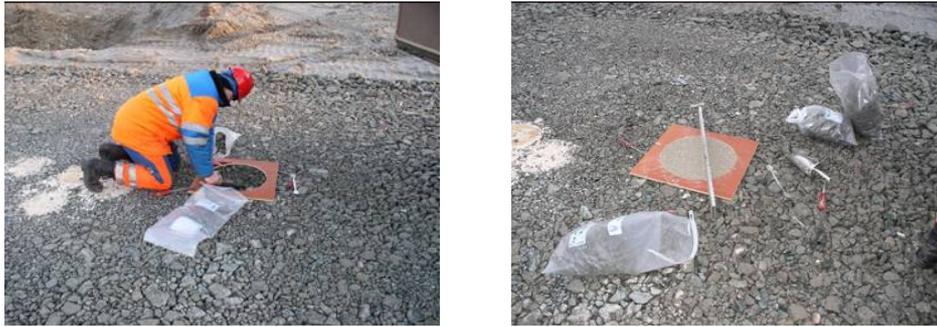
After compaction, the in situ dry densities were detected as shown in Figure 7. These values were to be used as input to the laboratory tests that followed.

**Figure 7:** In place detection of density/unit weight (sand replacement method)

Field densities and water contents were measured in situ after compaction (Figure 7). These became the target values when compacting specimens for triaxial tests in the lab. Two parallel samples of each fraction were tested. As can be seen from Table 5, the twin samples were almost identical.

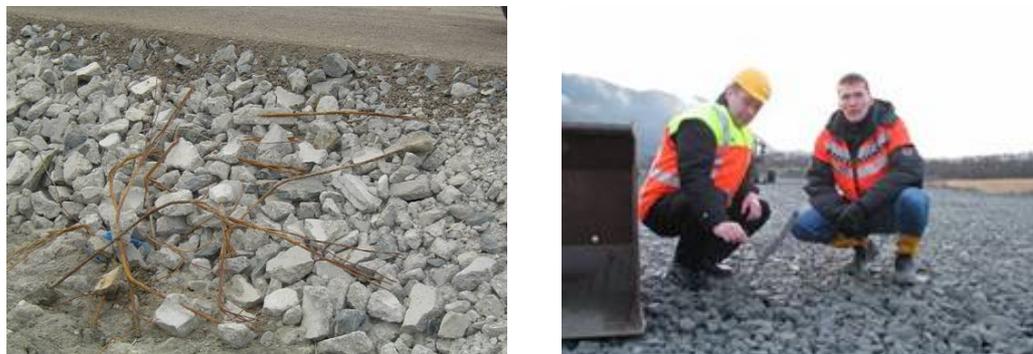
*Contaminants:* The importance of “clean”, well-sorted materials was also clearly demonstrated; during the first two hours of construction work three truck tires were punctured by remaining reinforcement steel bars!

**Figure 8:** Remaining steel bars may cause a lot of trouble

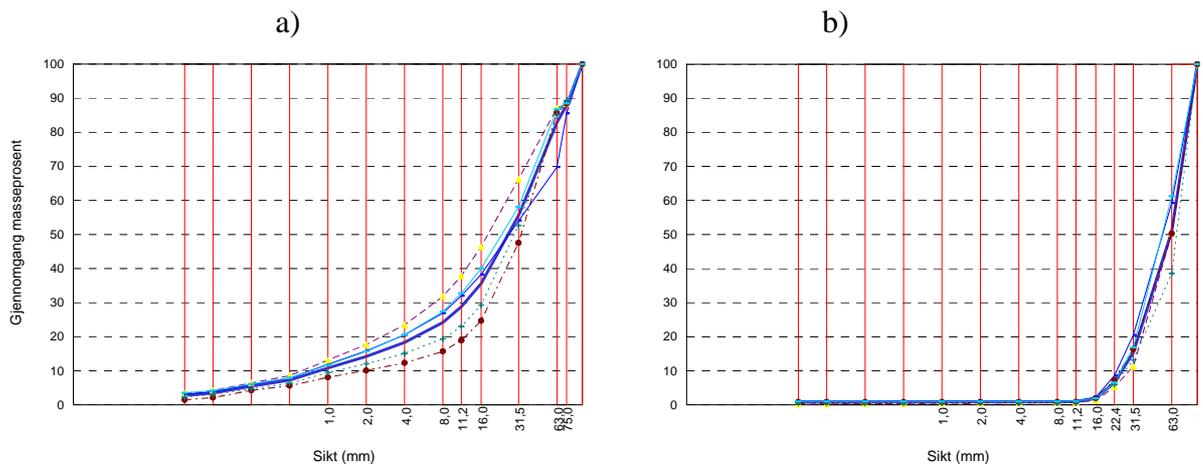
*Grading:* Particle size distributions for the two crushed concrete materials are shown in Figure 9. Bold lines show the medium curves (also used as target curves for the triaxial tests, see 5.3). The curves comply with grading requirements for granular sub-base materials in the Norwegian specifications (Handbook 018, 2005).

**Figure 9:** Crushed concrete before compaction; 0-100 mm (a) and 20-100 mm (b)

By comparing Figures 9b) and 10, the crushing and fragmentation of the coarser material during construction can be estimated. As mentioned, no significant differences in compaction effects were observed between the two rollers.

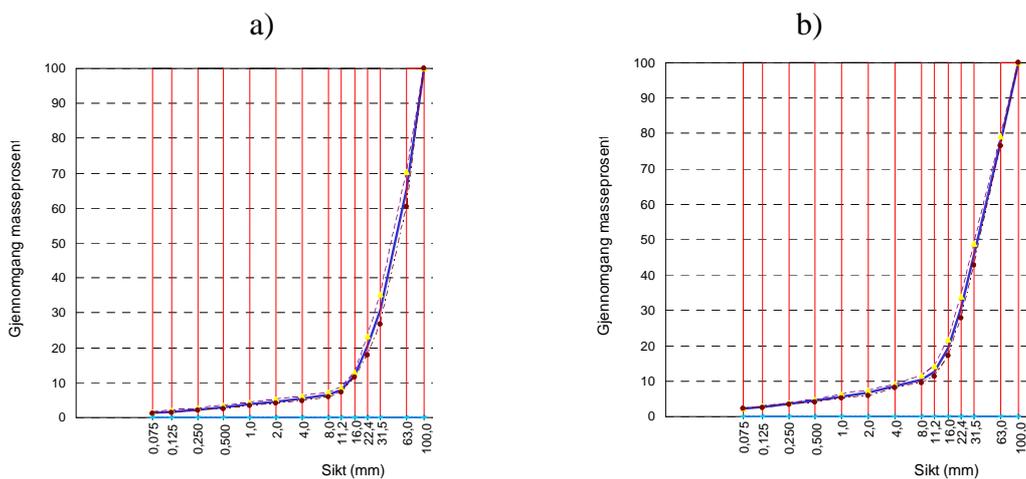
Curves for material samples taken on the road after compaction are shown in Figure 10.

**Figure 10:** Crushed concrete (20-100 mm) after compaction; 10 passes of heavy weight (a) and light weight (b) roller

When comparing Figure 13 to samples taken from field (Figure 10) we see that the curves for the open-graded material are almost identical. The materials seem to have

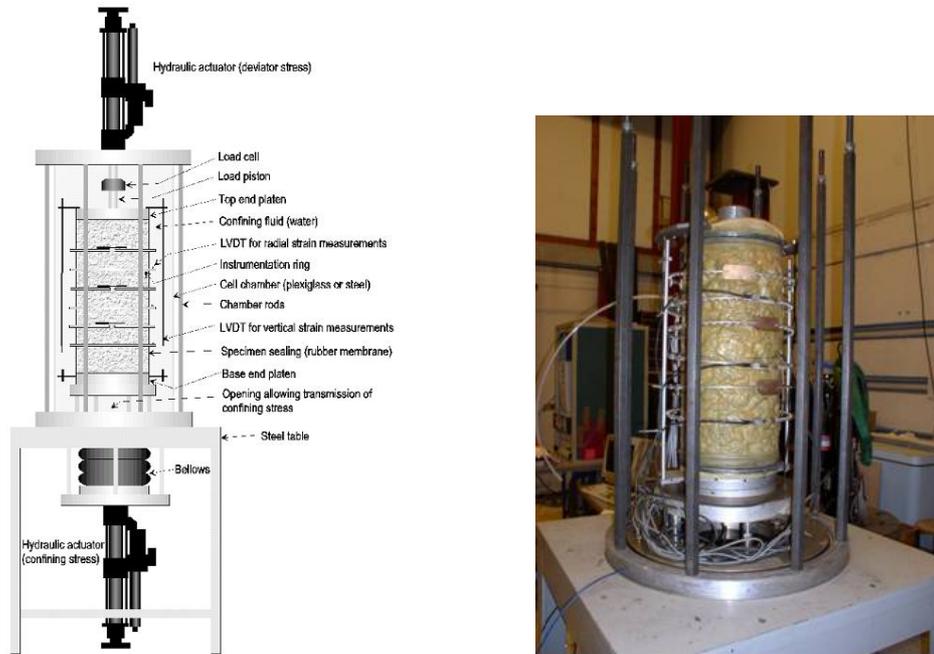
The testing apparatus, test procedure, sample preparation procedure etc is developed by NTNU/SINTEF in Trondheim (Skoglund, 2002). This equipment allows for testing materials with particle size up to about 60 mm. The apparatus is shown in Figure 11.

**Figure 11:** Large-scale triaxial test apparatus at NTNU/SINTEF with mounted specimen of crushed concrete from E6 Melhus

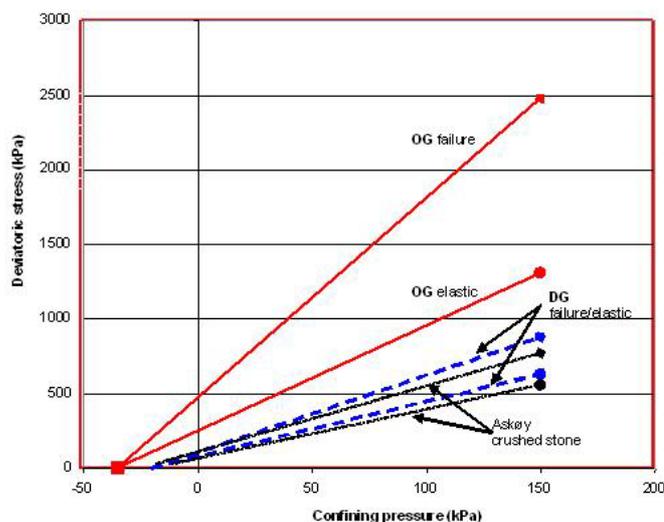
From repeated load triaxial tests both *elastic stiffness* and *resistance to permanent deformations* can be derived. The elastic stiffness is expressed by *E-modulus* for a given mean stress level, while the deformation properties are expressed by *elastic and failure angles* as shown in Figure 12.

**Figure 12:** Resistance to permanent deformations, crushed concrete E6 Melhus

Both failure and elastic angles are high (especially for OG) compared to natural granular base and sub-base materials. The results indicate that the crushed concrete materials should have very good properties regarding bearing capacity and stability (permanent deformation resistance).

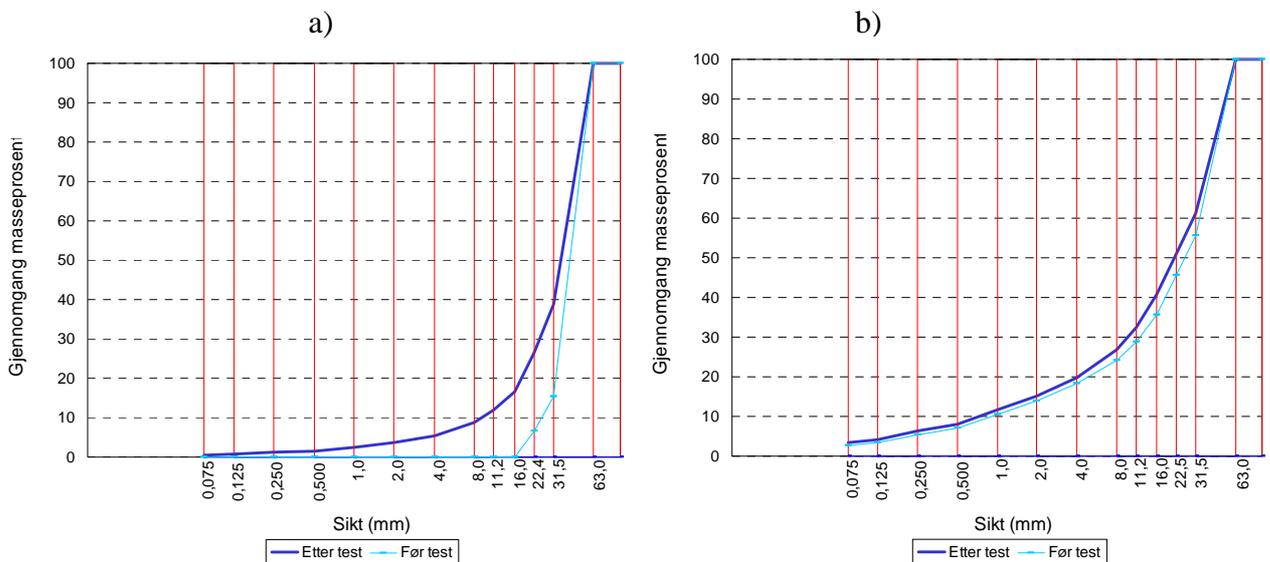
The triaxial test specimens were sieved after testing and the grading curves compared to the initial curves before testing as shown in Figure 13.

**Figure 13:** Grading curves before (thin) vs. after (bold) triaxial tests, samples OG1 (a) and DG1 (b)

had same crushing during field compaction as in the triaxial testing procedure. Thus, with the same densities and same water contents, the laboratory results should give a representative picture of the material properties in field.
