Unbound crushed concrete in high volume roads – Evaluation of field behavior and structural performance

J. Aurstad & J. E. Dahlhaug

Norwegian Public Roads Administration, Trondheim, Norway

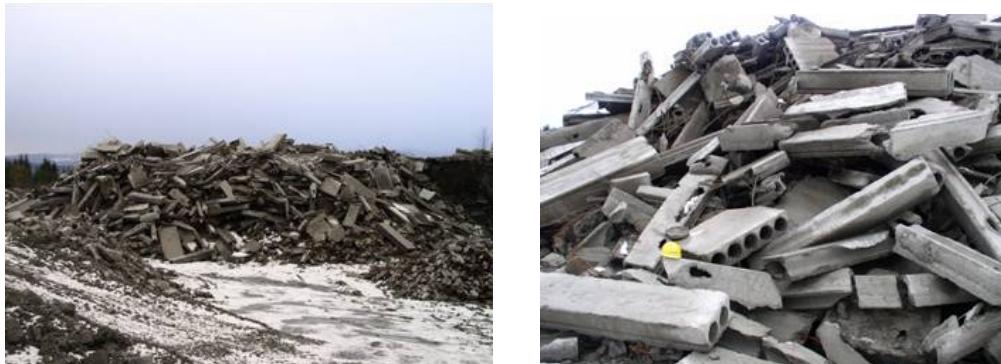
The origin of these alternative sub-base materials was discarded pre-fabricated element concrete, as shown in Figure 3.

Figure 3. Element concrete stockpile

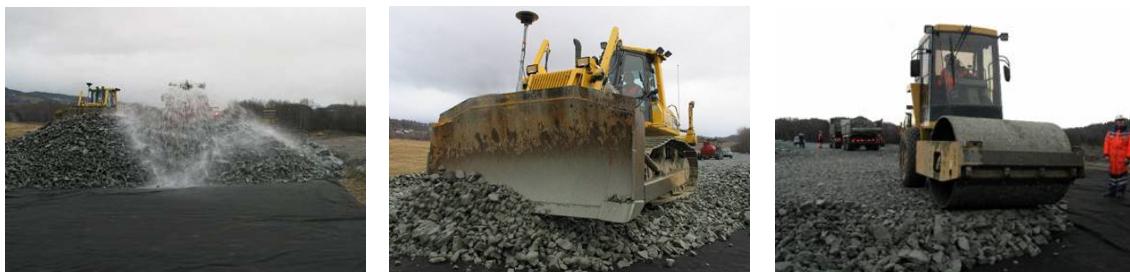
The concrete elements were crushed in a mobile crushing mill which also separated (most of) the reinforcement. The crushed materials were then fractionated into the two required products, 0-100 mm and 20-100 mm (Aurstad et al 2005). After transportation to the test site, the materials were sprinkled with water before compaction in two layers á ca 30 cm (Figure 4).

Figure 4. Sprinkling of the crushed concrete materials was recommended before paving and compaction

Workability: The contractor on this job had no previous experience with recycled materials and was rather sceptical. This caused discussions regarding procedures, type of rollers, need of water sprinkling etc. The effect of abundant water addition was soon clearly demonstrated, both visually and by levelling and plate bearing measurements. The materials performed very well during laying and compaction and only minor crushing and disintegration was observed. The workers were certainly positively surprised by the behaviour of the materials.

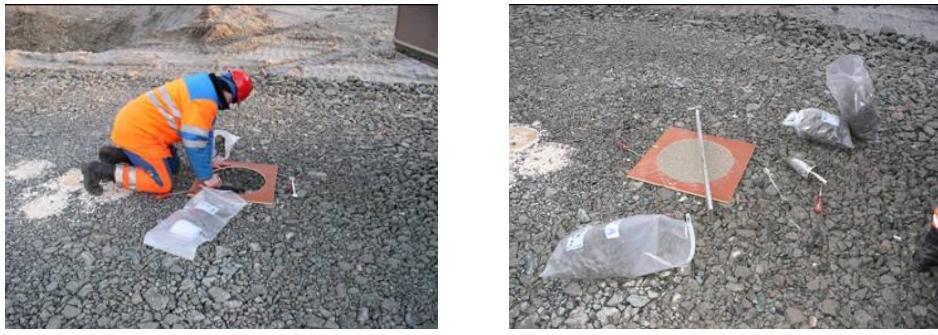
After compaction, the in situ dry densities were detected as shown in Figure 5. These values were to be used as input parameters to the laboratory tests that followed.

Figure 5. In place detection of density/unit weight (sand replacement method)

The tests were carried out in accordance with EN 13286-7 “Unbound and hydraulically bound mixtures Part 7: Cyclic load triaxial test for unbound mixtures”. The specimens were compacted with same water content and to same density as measured in field (Figure 5). Open-graded and dense-graded material were compared by down-scaling the field materials from 0-100 mm/20-100 mm to 0-63 mm/20-63 mm. The testing was performed at stress levels equivalent to the sub-base conditions in field (on a road with heavy traffic).
