Plastic Foam in Road Embankments

Norwegian
Road
Research
Laboratory

CONTENTS

OUTLINE OF ALTERNATIVE SOLUTIONS AND THE VARIOUS APPLICATIONS OF EXPANDED POLYSTYRENE AS A LIGHT FILL MATERIAL IN NORWAY.

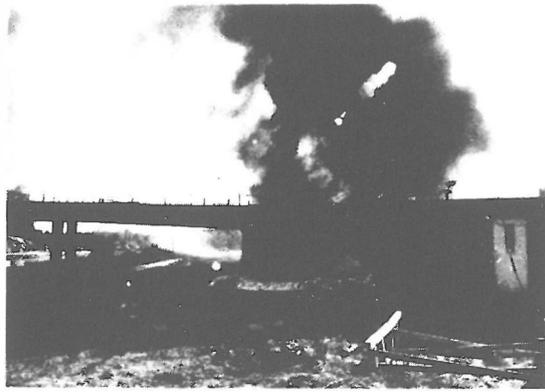
Fig. 9 EPS embankments in fire.

So far, there have been two accidents where EPS-blocks went up into smoke, one stockpile and one fill. The 1500 m³ EPS embankment leading up to Knatten bridge was accidentally set on fire 2 years ago because of badly planned welding works at the bridge abutments. After 15 minutes about 35.000 dollars had disappeared up in the air. A consequence of this fire is that the District of Akershus, where this happened, now specifies self extinguishing EPS for their projects. This may be a somewhat strict requirement and should not be a practice generally followed. Proper planning and well-organized construction sites should make the choice of self extinguishing quality unnecessary for many projects.

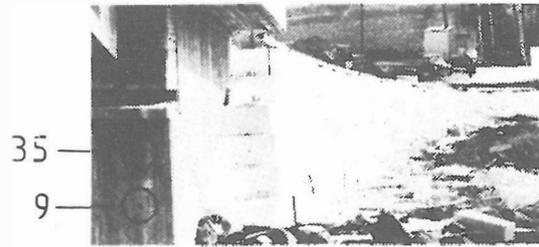
BRIDGE ABUTMENT

The horizontal pressure is significantly reduced by using EPS instead of conventional materials. Knowledge of EPS material can be very useful when designing high bridge abutments and retaining structures. An example is Lambertseterveien bridge (see case histories) where the abutment, which is 1,5 meter thick and piled to rock, was built in a traditional way able to take care of earth pressure as if the embankment was made of heavy materials. During the construction, a gap was made between the EPS fill and the abutment wall, which theoretically should indicate no earth pressure on the abutment wall under the concrete slab. The compressive stiffeners in the formwork were hollow pipes, leaving holes through the front wall. Through these holes the distance between the EPS fill and the abutment has been measured 7 years later and there is still a gap to be observed except for a small area. The conclusion is that there is almost zero earth pressure against the abutment wall.
