# **The Prevention and Repair of Salt Damage to Roads and Runways**

Ministry of Works, Transport & Communications,  
Roads Department  
Private Bag 0026  
Gaborone, Botswana  
Phone + 267 - 313511  
Fax + 267 - 314278

**JULY 2001**

### **Guideline No. 6 The Prevention and Repair of Salt Damage to Roads and Runways (2001)**

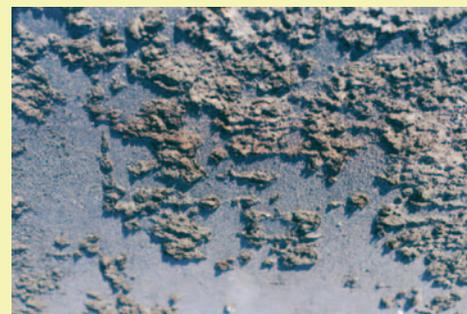
*Blistered bituminous prime due to salt crystallisation (Nata-Maun road).*

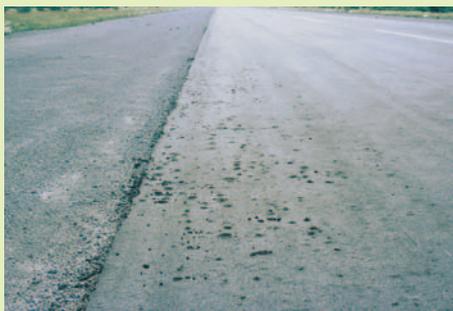
*Domed cape seal surfacing due to salt attack Sua Pan Airstrip.*

The Sua Pan airstrip was constructed in 1988. The pavement comprised calcrete subbase and base with a Cape Seal bituminous surfacing. Within six months after construction, the surfacing developed star shaped blisters and domes ranging in size from a few millimetres to 15 mm in diameter and 1 to 5 mm in height. The damage occurred initially in the untrafficked edges of the runway and progressed towards the centre of the runway. Some of the domes had opened up to reveal clusters of white salt crystals.

Preliminary field investigations and X-ray studies at University of Birmingham showed that the salts originated from the saline subgrade and comprised of sodium chloride and Trona salt (sodium hydrogen carbonate or “soda ash”).

A number of remedial measures were considered including bitumen rubber reseal to increase impermeability. It was finally decided to remove and reconstruct the damaged parts of the runway with concrete pavement slabs. An alternative solution would have been to reconstruct with an impermeable plastic layer placed at the top of subgrade to prevent upward salt migration.

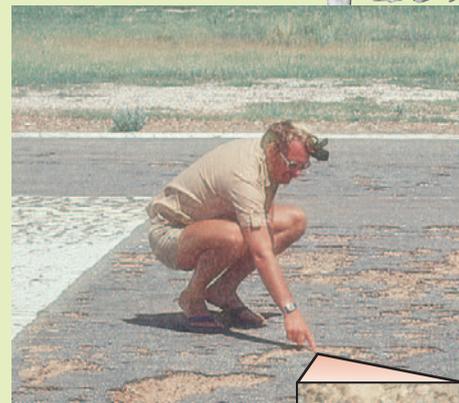
*Salt attack Sua Pan Airstrip.*

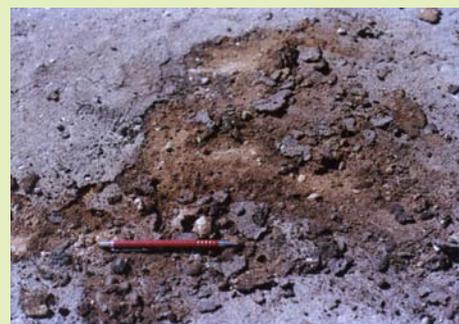
*Powdered cutback prime and top of base course due to salt attack. Nata - Maun road.*

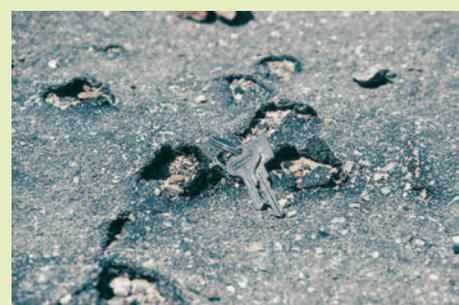
*Salt blistering on the Sekoma - Kang road.*

The salts had originated from the saline water used for compaction of lower pavement layers. The salt had migrated to upper pavement layers. Table 2.1 shows the distribution of salt within the pavement approximately 13 months after construction. There had been a general increase in salt content under the surfacing (0-50 mm) indicating a need for timely reseal to prevent evaporation and consequent salt damage.

Remedial measures included removal of the damaged single seal and reseal of the carriageway. Severely damaged sections of the shoulder were removed and reconstructed. In areas of less severe damage material in the area surrounding the dome was dug out approximately to 20 mm diameter and 50-100 mm depth) and replaced with an emulsion based premix. As shown in table 2.1, salt is still present in the pavement and it will be necessary to maintain impermeability by timely reseal in order to avoid further salt damage.

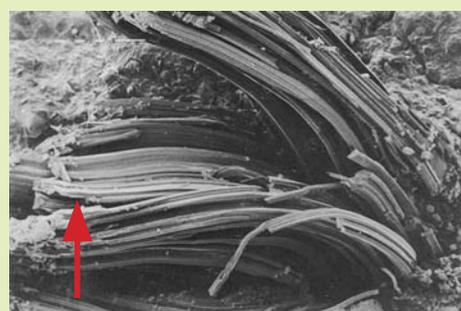
*Microscopic sized salt whiskers breaking through road surfacing. This type of crystal causes maximum damage due to high pressures.*

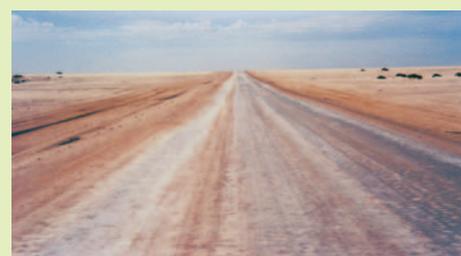
Gravel road on saline ground with addition of salt water sprinkle. Road near Swakopmond, Namibia.

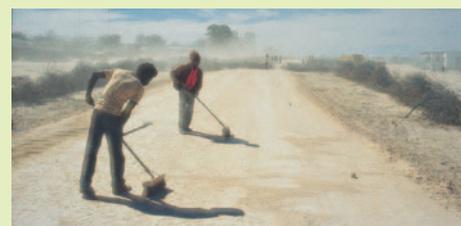
Brooming was used successfully on parts of Sehitwa-Tsau, Tsau-Gumare and Tsabong-Makopong roads.

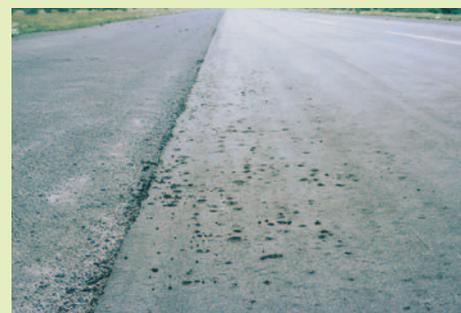
*Salt damage to shoulders. Damage will normally start at the shoulders and progress to the centre of the carriageway. This is due to high evaporation and less traffic at the shoulders.*

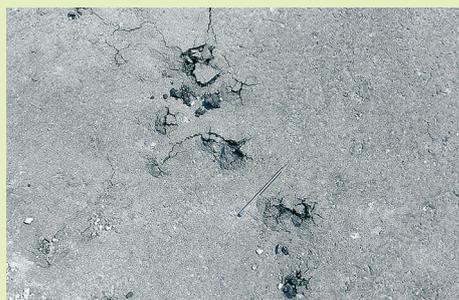
Salt damage is often observed within days after priming or up to 2-3 days after surfacing. Tsabong - Makopong road.

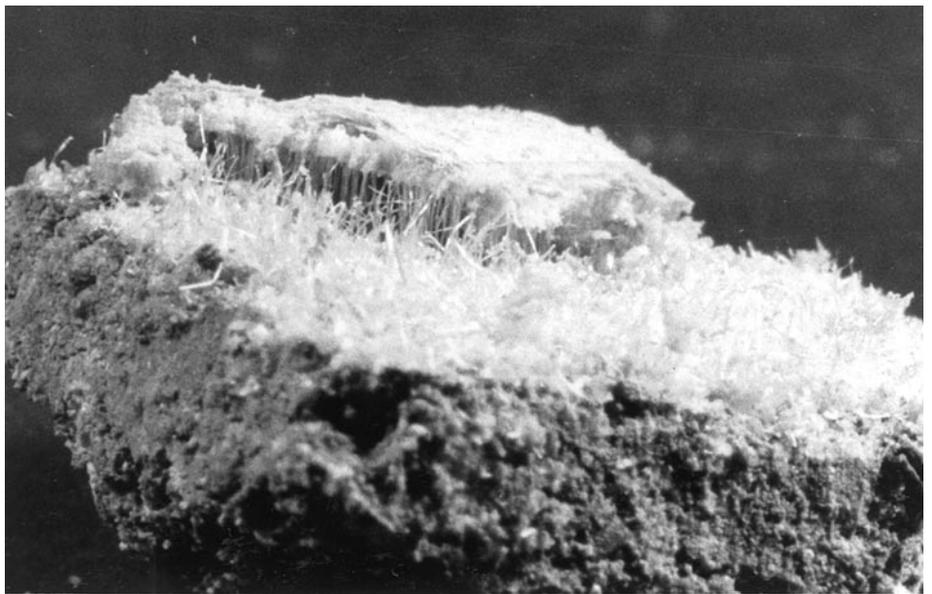
*Whisker NaCl crystals cause maximum damage.*

An alternative is to ensure that supersaturation does not occur. High supersaturation results in the formation of the most deleterious type of salt crystals with high growth pressures. These crystals are known as filamentous crystals or salt ‘whiskers’.
