Washington State's Floating Bridges

Lessons Learned

Nicholas T. Rodda, PE, SE
Floating Bridge and Special Structures Design Manager
November 1, 2018

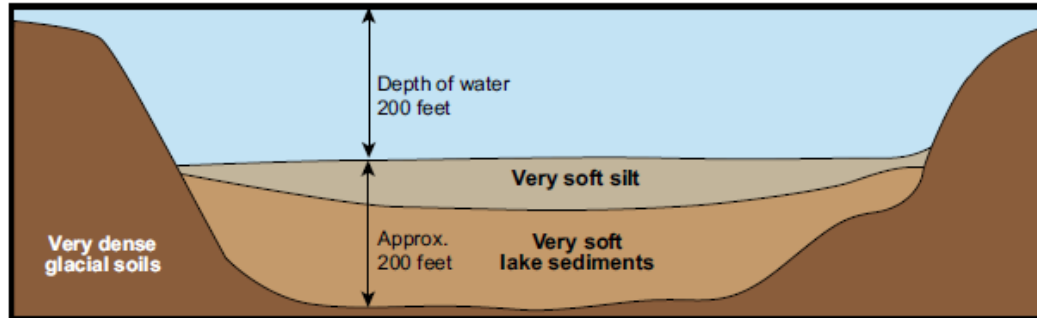
Lake Washington's topography

- Lake Washington is over 60m deep and is underlain by another 60m of very soft material.

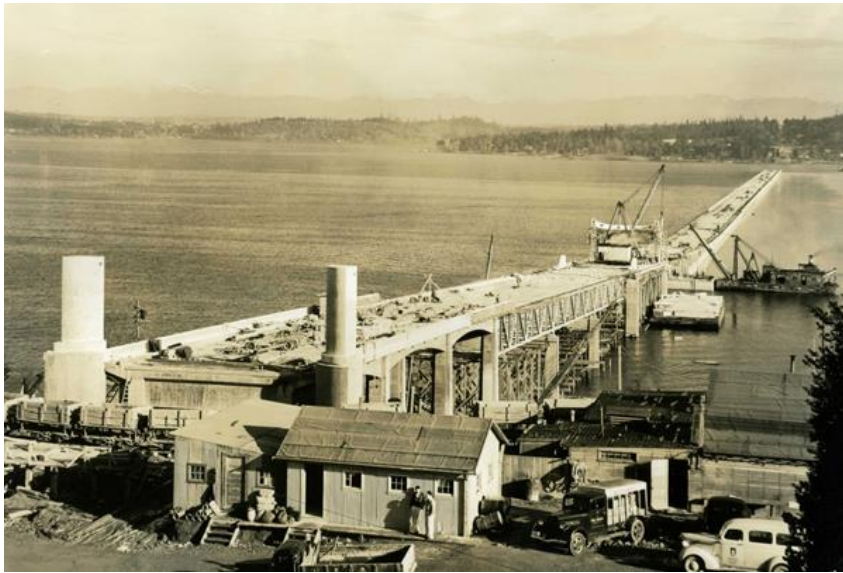
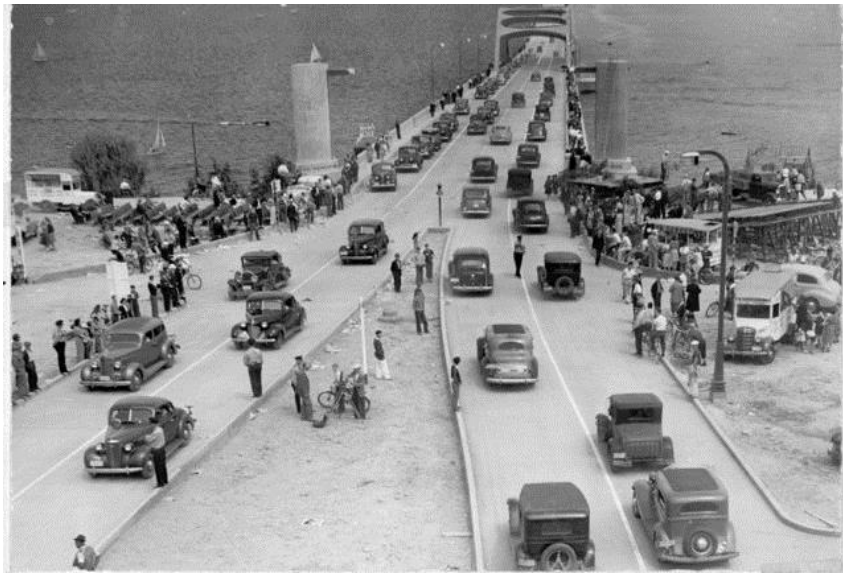
- Typical long span bridges in these locations would require tall towers, which is out of character with the local topography.

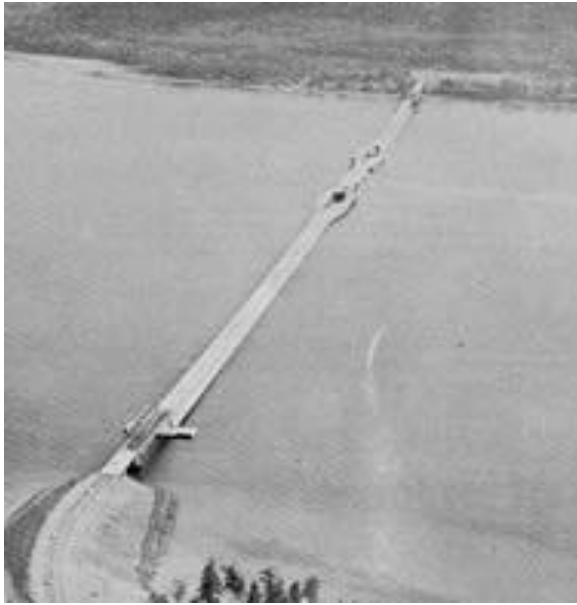
- LVM has seen many improvements over the years
- Elimination of free water ballast
- Draw span was removed in 1981
- Bridge was originally 4 lanes, with two way traffic
- At certain times of day, one lane would be reversed
- This led to many accidents on the bridge.

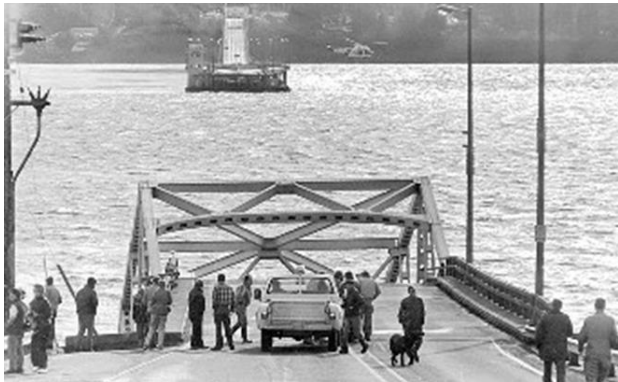
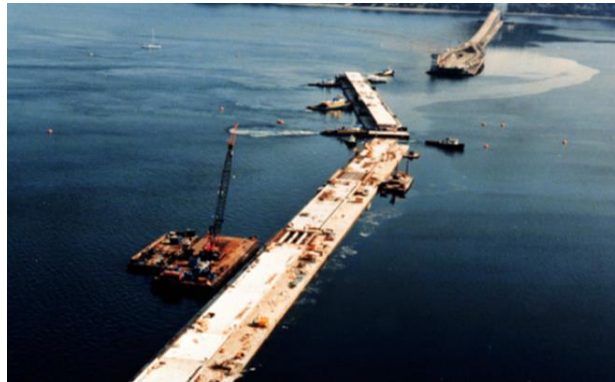
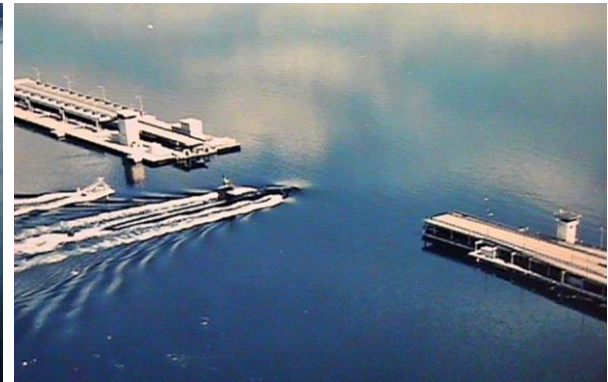
Hood Canal Sinking

- On February 13, 1979, a windstorm caused the west half of the Hood Canal bridge to sink.
- Sustained winds of 85 mph with gusts to 120 mph.
- In 1982, a new west half was opened to traffic.
- Built in phases, pontoons R, S & T were built to take the position of the west half draw.
- When the new draw was ready, R, S & T were removed and moored in nearby Port Gamble bay
- West half draw uses flanker pontoons and hydraulic lift spans instead of a “bulge”

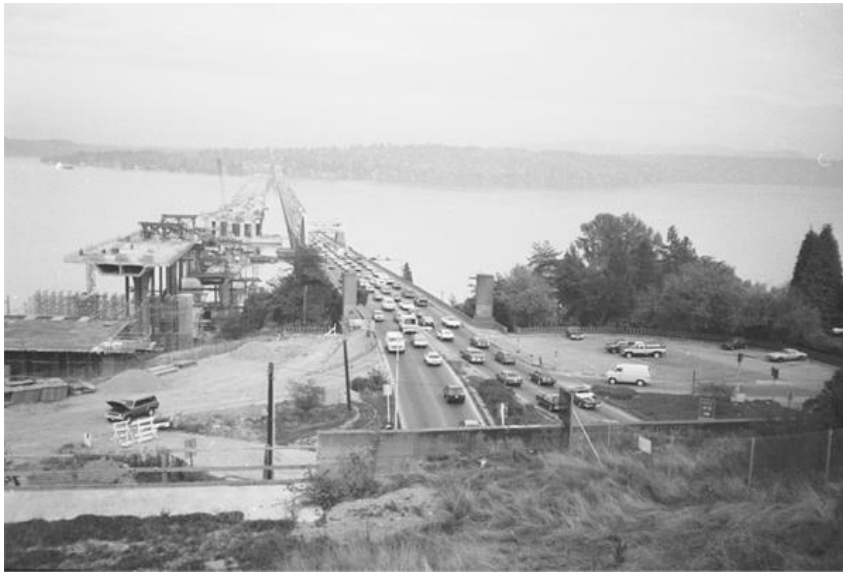
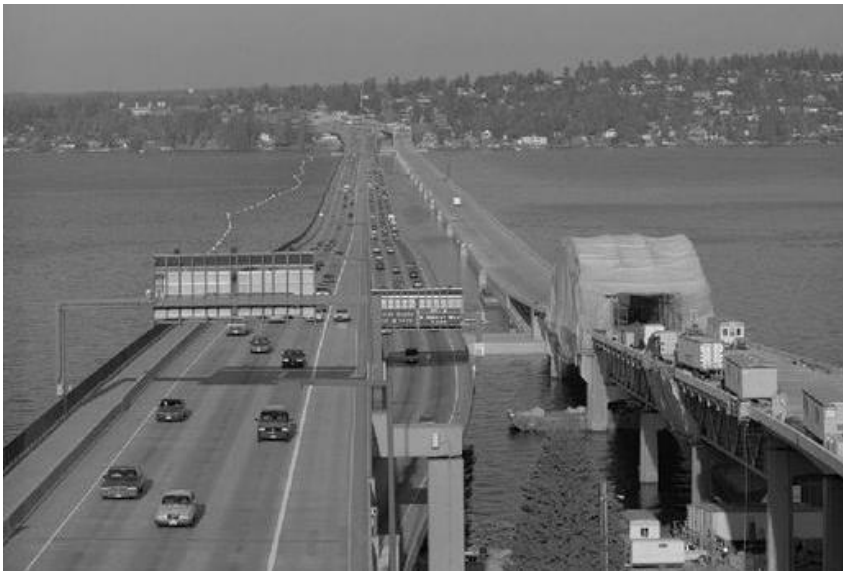
- Plans for a parallel 520 span were rejected early on
- Bridge routinely closed for winds exceeding 50 mph
- Modernization of the draw span increased reliability and safety
- A center barrier was added
- Each half of the bridge was longitudinally post-tensioned for strengthening
- Weight of these additions reduced freeboard

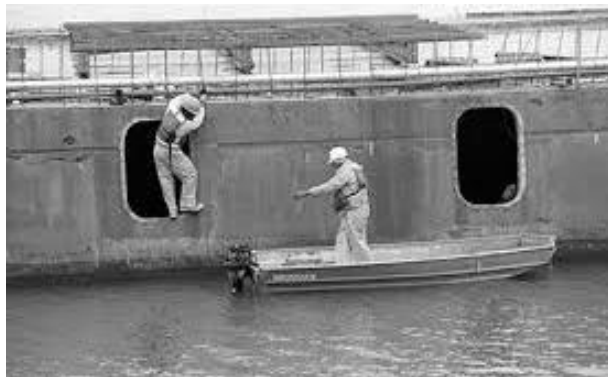
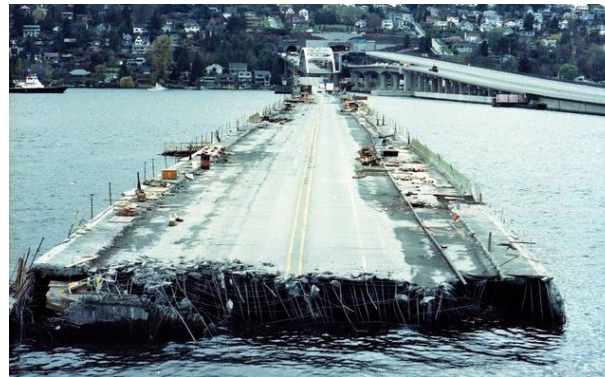
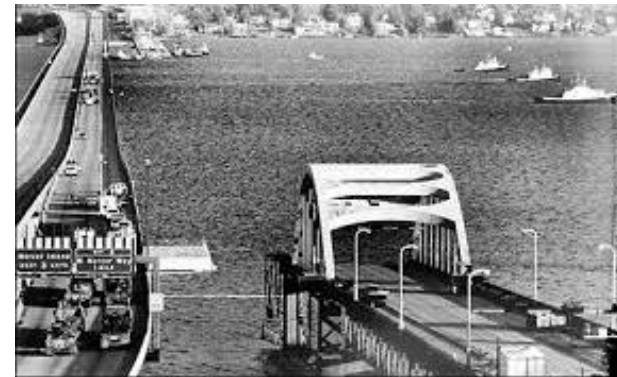
Disaster on Lake Washington

- The Murrow bridge closed in 1989 for renovation
- Among the modifications planned were hatches in the walls to permit maintenance access and hydro-demolition of the corners to remove curbing to widen the bridge
- During construction, the Contractor elected to temporarily store hydro-demolition water in the pontoon cells
- In some places, the side hatch holes only had 125mm of freeboard and were left open
- A windstorm hit during the Thanksgiving holiday weekend in 1990.
- Unattended during the holiday, water was allowed to enter the bridge and compromise the bridge's buoyancy
- The bridge sank on November 25, 1990

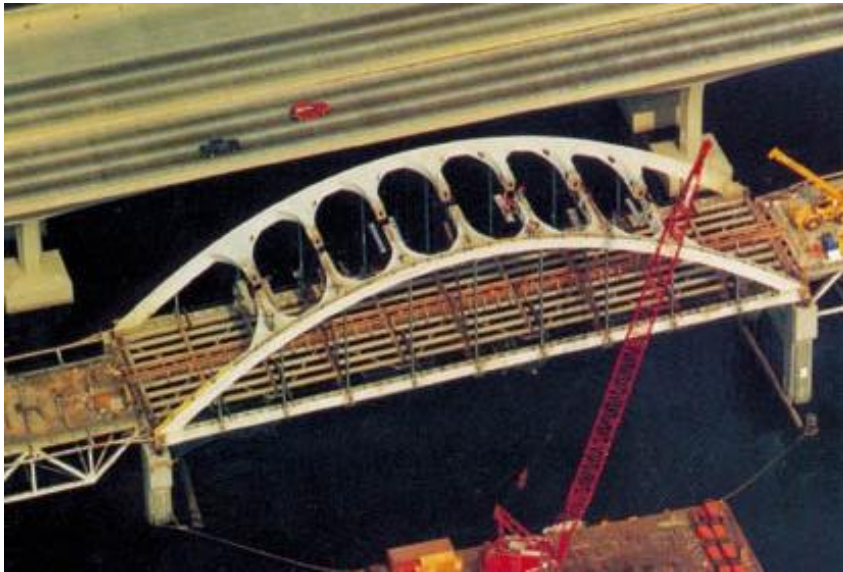
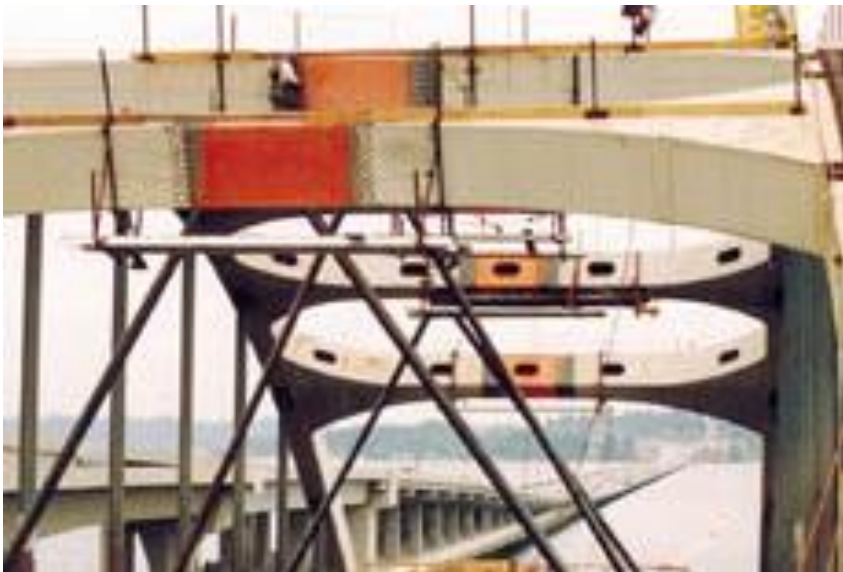
- When LVM sank, it severed 13 of the nearby Third Lake bridge cables
- Bridge drifted 1m to the North
- Tugs were dispatched to hold the bridge in place
- Bridge was stabilized within 4 months

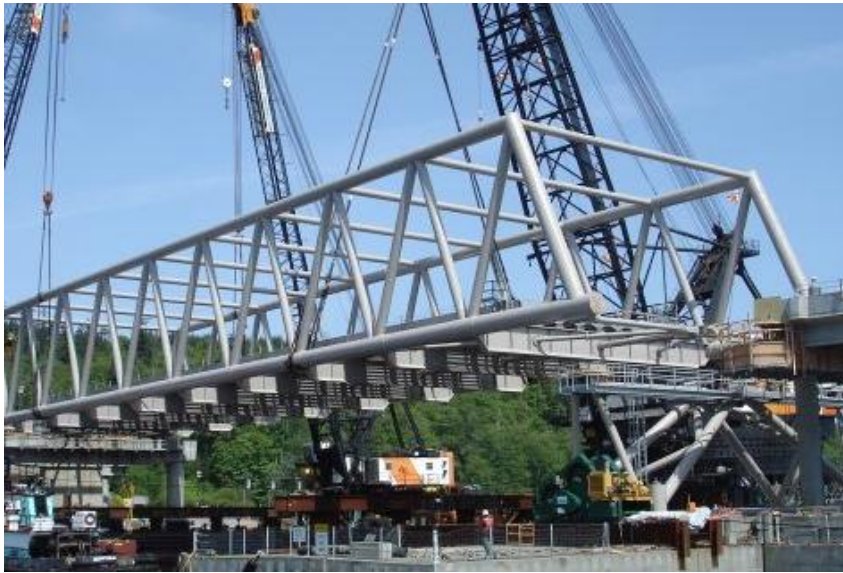
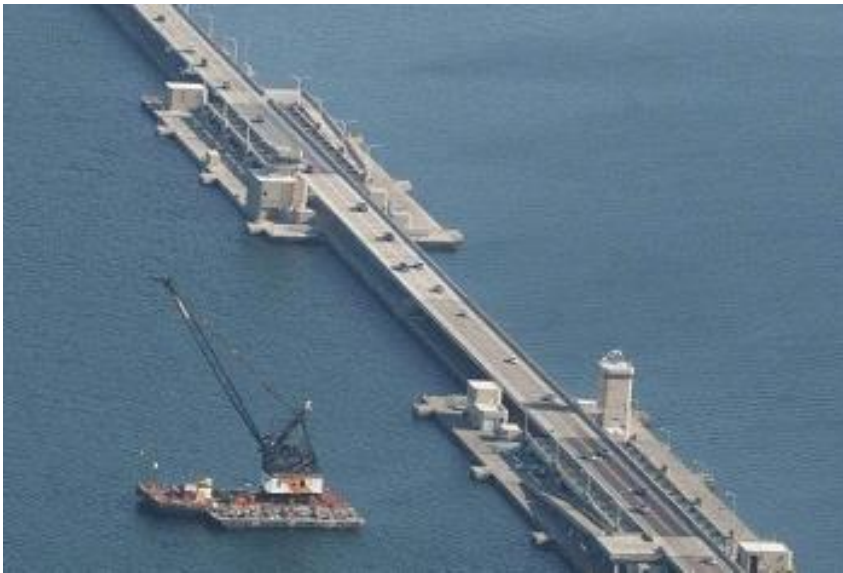
- As a result of the sinking, the bridge re-opening was delayed until 1993
- Blue Ribbon Commission was formed by Gov. Booth Gardner to study the causes of the I-90 bridge sinking
- The new bridge was built using the experience of nearly 50 years
- Signature arches were widened
- Maintenance access cells were an addition which allow bridge crews to enter the pontoons away from traffic
- Other improvements included offset anchor galleries, dedicated in cell jacks for adjusting cable tension, full lighting, water level sensors

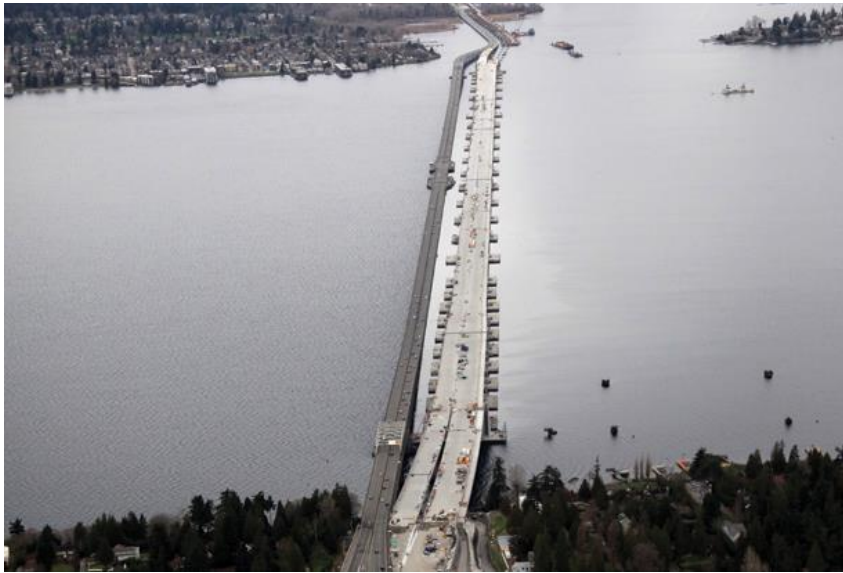
- Plans to replace the ageing East half of Hood Canal began in 2003
- Both approaches were replaced
- Both transition spans replaced
- West half was widened to include a shoulder
- Features epoxy coating on all reinforcement and strand with increased cover
- Bridge re-opened to traffic in 2009

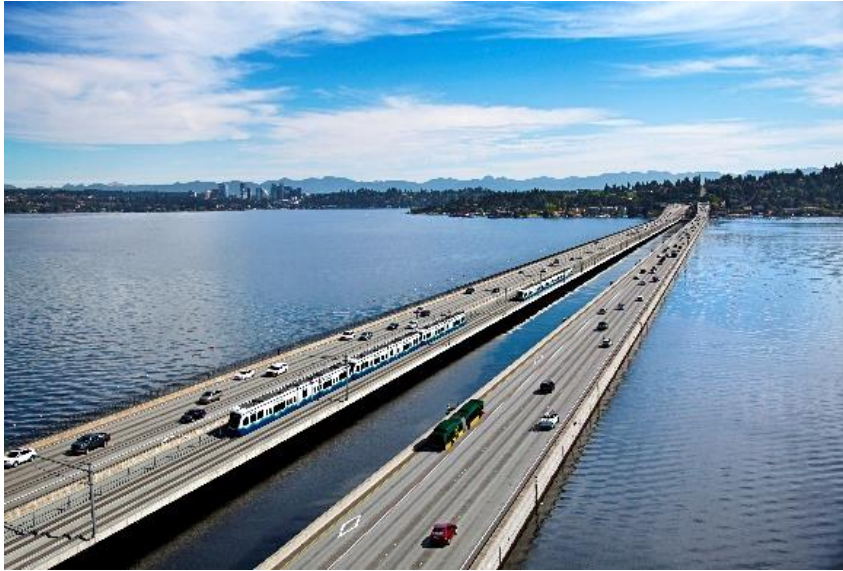
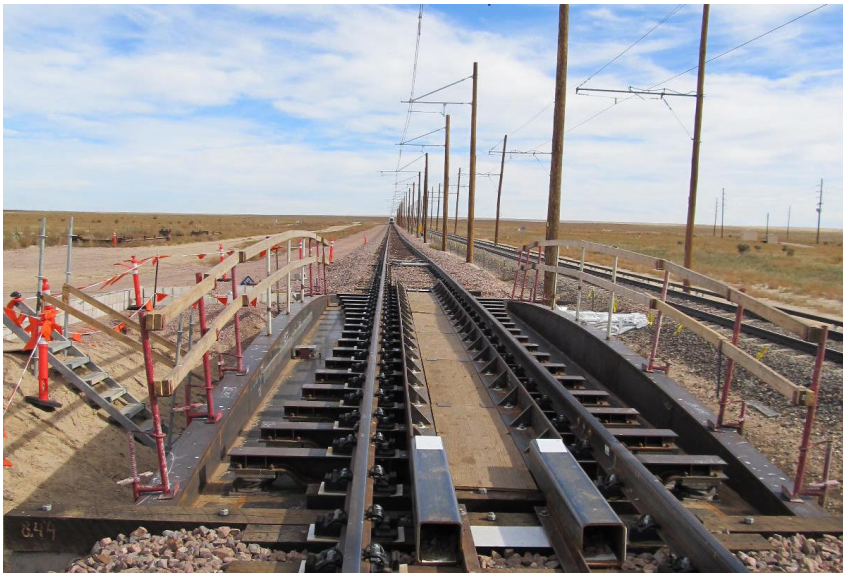
- Currently our oldest floating bridge components are the west half of Hood Canal (c. 1982)
- pontoons R, S & T also date back to 1982.
- West half girders are in poor condition and will likely require replacement within the next 5 years
- A preservation contract for Hood Canal is ongoing
- WSDOT has 210 anchor cables in it's inventory
- Anchor cables generally have a life of 25-30 years
- Anchor cable replacements will continue to be a major preservation item.
