MAINTENANCE MANUAL

REBLOC[®] ROAD RESTRAINT SYSTEMS

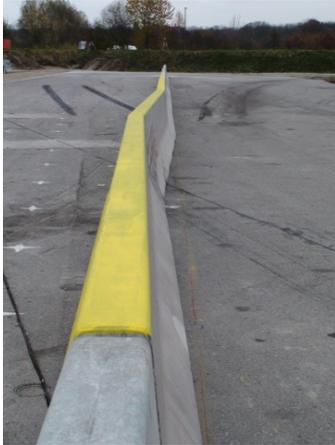
system lightly displaced

- 2) If there is no damage / crack formation visible, nevertheless the system has been displaced, it is sufficient to replace the effected barriers in their original location (see installation instructions).

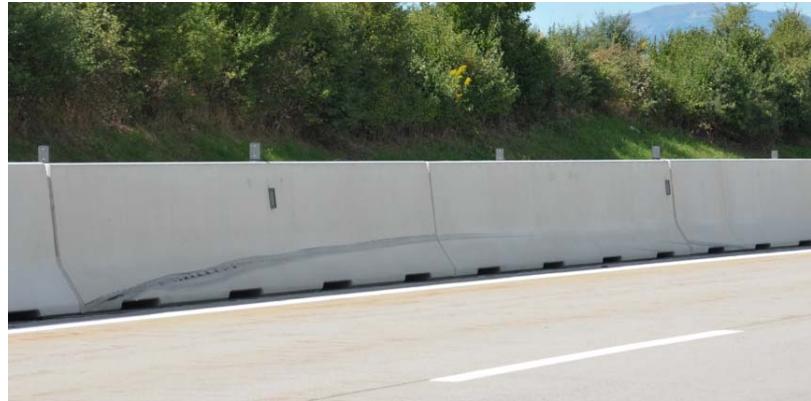
abrasion marks, system not damaged

- 1) If there are just scratches and / or abrasion marks visible but no cracks and no deflection of the system no maintenance / repair works is necessary.
